Boeing 747-300 Cockpit Restoration Project Timeline & Development

For end use as a home flight simulator

Boeing 747-3H6, Serial number 23600, Total aircraft hours: 64141, Total cycles 13470, Last registration: B-KAC Dragonair Cargo, (Cathay Pacific) Hong Kong

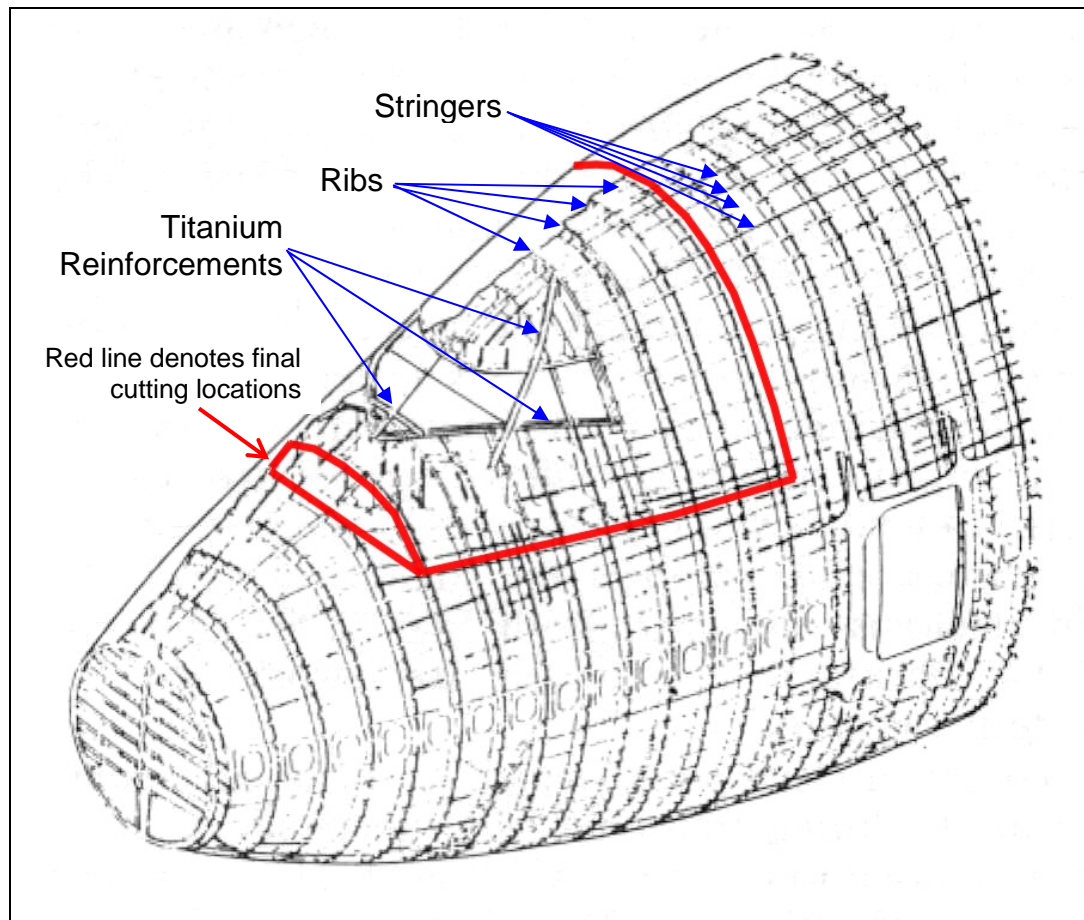
Boeing 747 interior structure in the vicinity of the cockpit
(Red lines delineate where cutting took place)

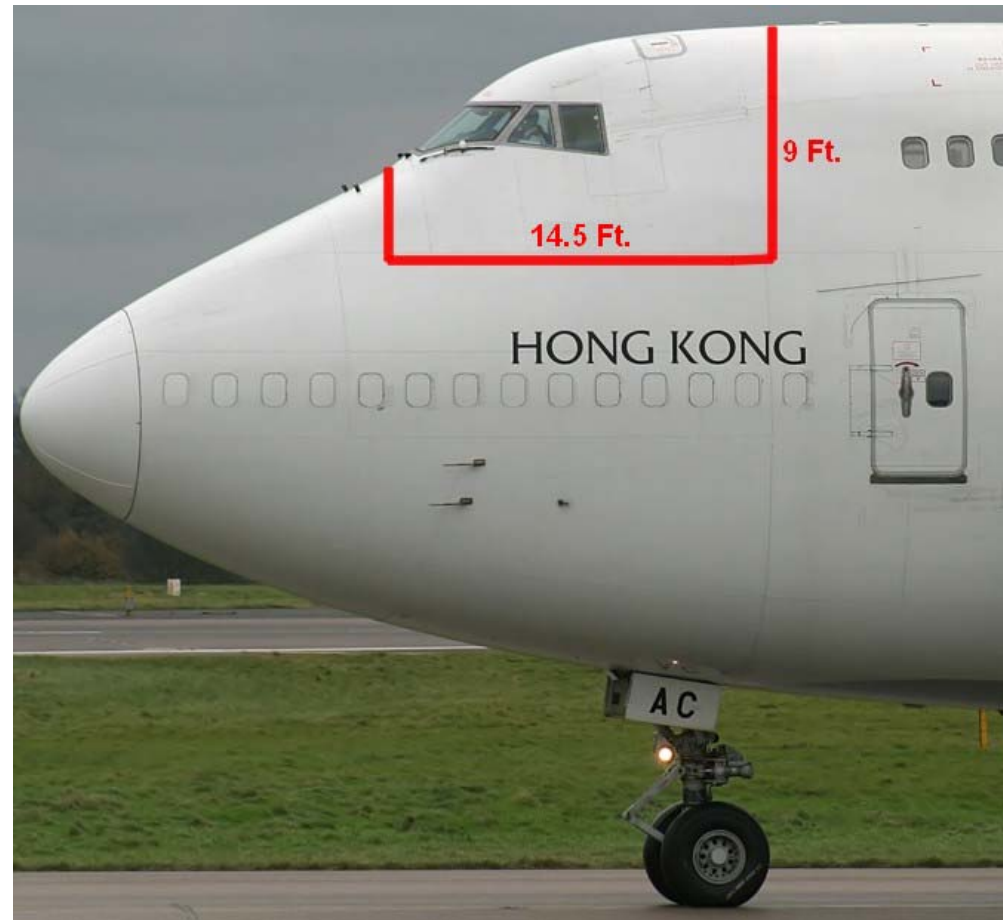
Actual aircraft depicting where the cuts on the structural diagram (left) appear on the exterior fuselage and the approximate length/height

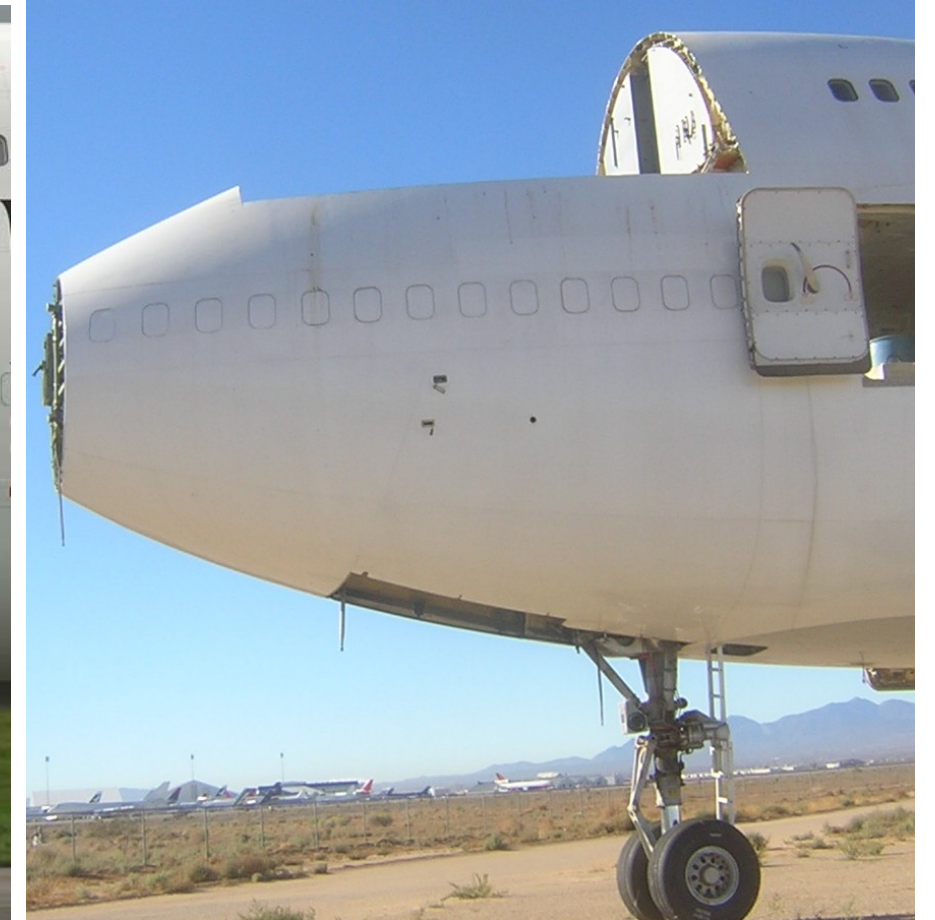
Same aircraft with the cockpit removed. Was cut further forward than necessary for easy removal, then trimmed further on ground

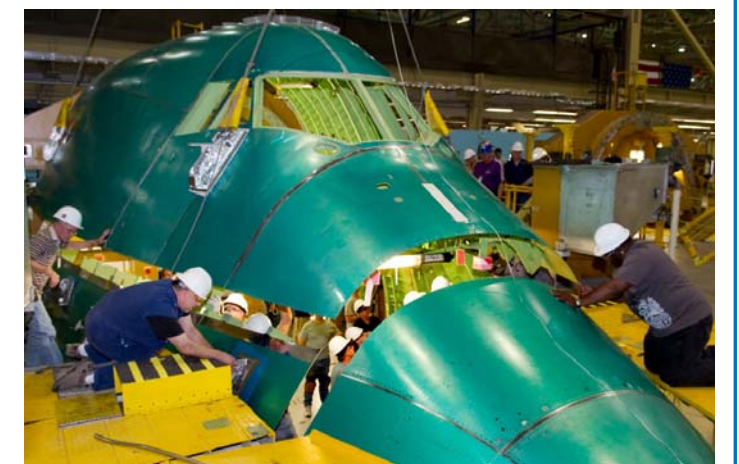
Pictured on the right is a 747 Cockpit (Section 41) being carefully attached to the rest of the fuselage during final assembly at Boeing.

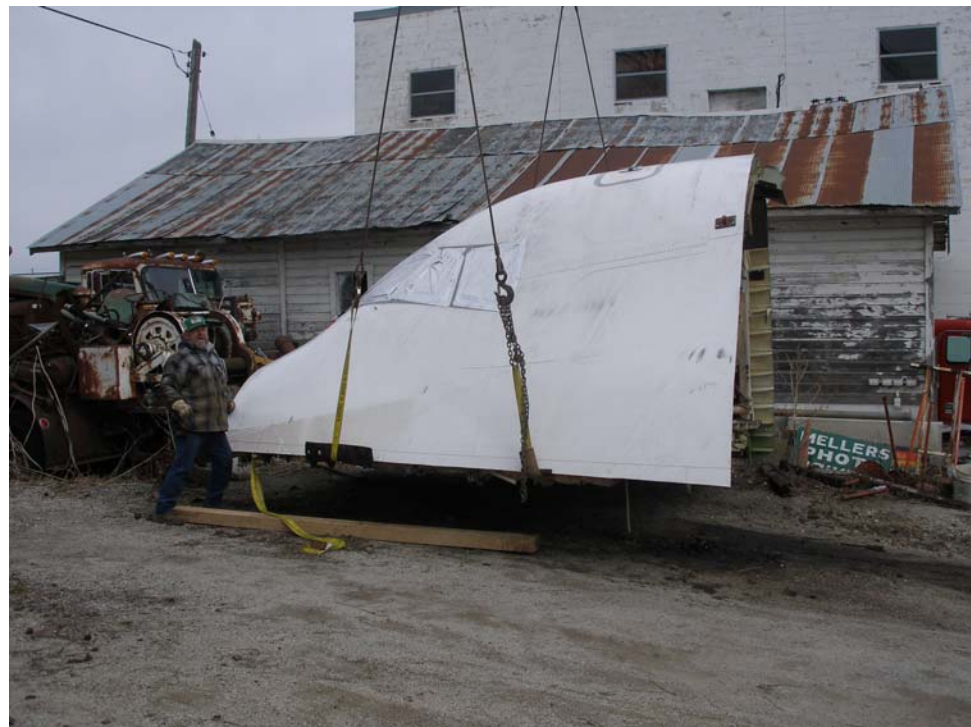
The cockpit was lowered onto wood planks to avoid the sharp Cut edges from digging into the ground and making difficult to Place straps beneath it for its final delivery to the house

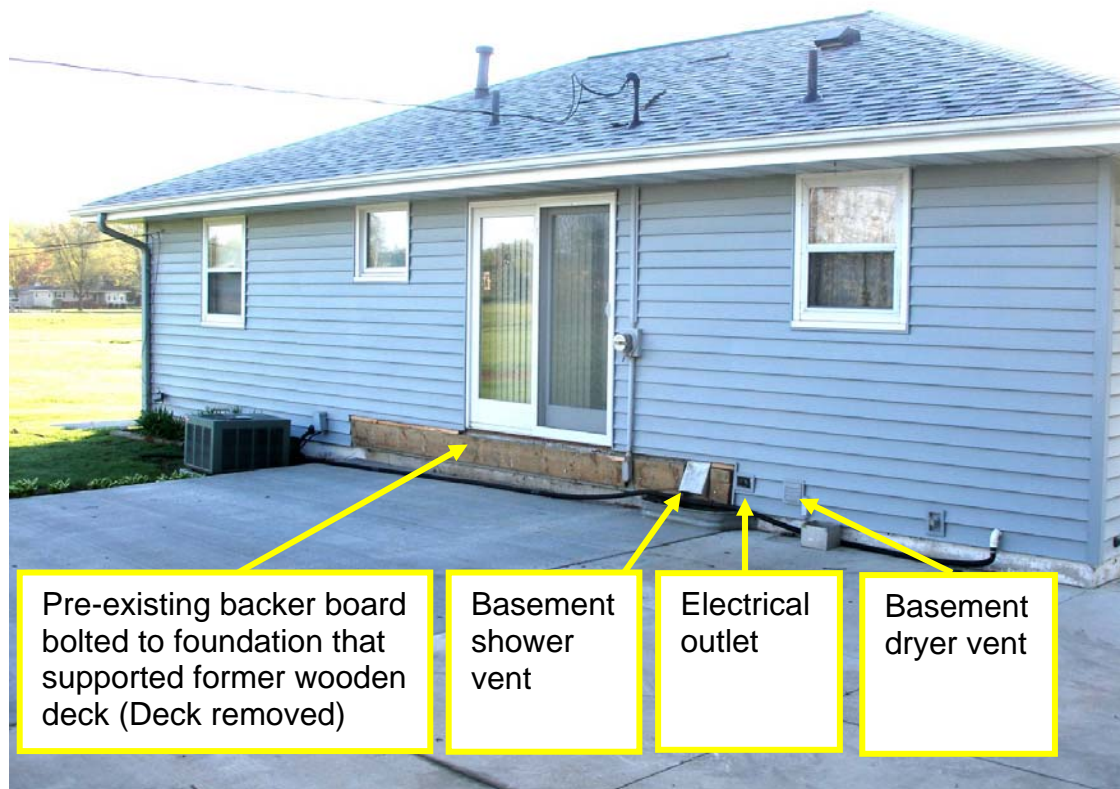
Rear of house before 747 cockpit placement

Pre-existing backer board bolted to foundation that supported former wooden deck (Deck removed)

Basement shower vent

Electrical outlet

Basement dryer vent

- The wooden deck was disassembled and all wood recycled
- The large deck support board bolted to the house's foundation was left in place
- The basement shower vent and electrical outlet was obscured by the bridge between house and cockpit floor
 - The shower vent was simply routed to the outside of the bridge structure
- The electrical outlet was left undisturbed and unused
- The dryer vent was left undisturbed
- Multiple new ducts were cut through the wall connecting the flight deck's complex original air circulation system to the home's heating and air conditioning system. Two large air ducts existed at the rear of the cockpit that accepted the main flow from the aircraft's air conditioning system and distributed that air throughout the cockpit. A third large duct was routed downward behind the flight engineer's station that was used exclusively for equipment cooling.

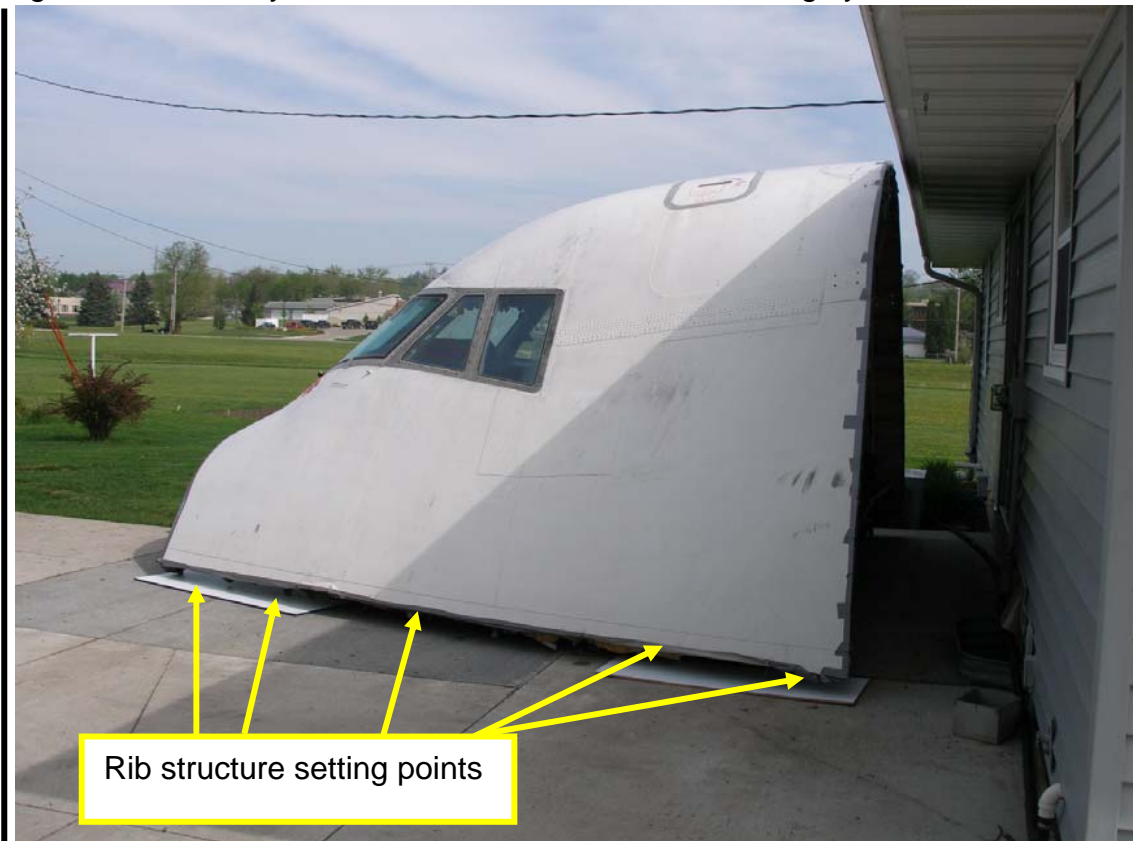
Rib structure setting points

Cockpit placed slightly ahead of the gutter

- The cockpit was lowered onto the ground with ribs resting on ½" plywood sheets with a top layer of laminated plastic
- The cockpit floor is even with kitchen floor behind the sliding glass doors
- Several 2x4s with ¼" aluminum plates on top were placed under additional fuselage ribs to provide evenly distributed weight and insurance against any settling. (Aluminum plates prevented the sharp cut rib structure from piercing through wooden 2x4s)
- The gap between cockpit floor and house was three feet
- The entire aluminum airframe was grounded to earth ground via a copper rod driven deep into the soil wired to a heavy cross-member floor spar. Luckily, no lightning strikes hit this very large conductive target while it was exposed outdoors.

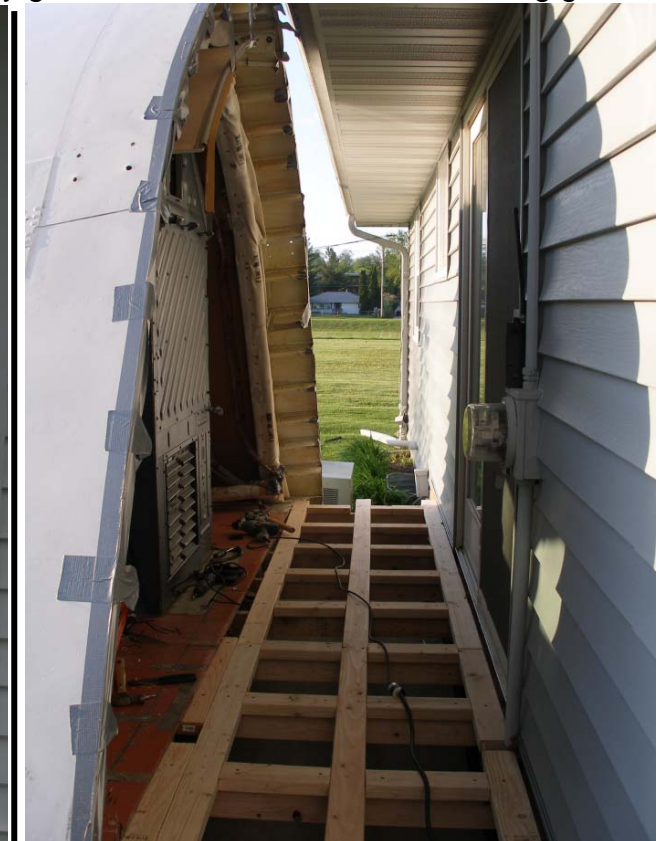
Bridge built to between cockpit and house

- Nine 2x4 cross-members spaced 18" apart between cockpit and old deck backer board
- Three 2x4 spans screwed to top of the 9 cross-members
- 2x4s placed on top of each cross-member between the spans
- House side attached via same type of board support metal cradle hardware as the former deck used.
- Cockpit side uses the same support cradles attached to rearmost under-floor support spar.
- All attachments used screws exclusively to enable easy disassembly & maximum strength (No screws went through siding!)
- Intentionally over-built to exceed any expected loads

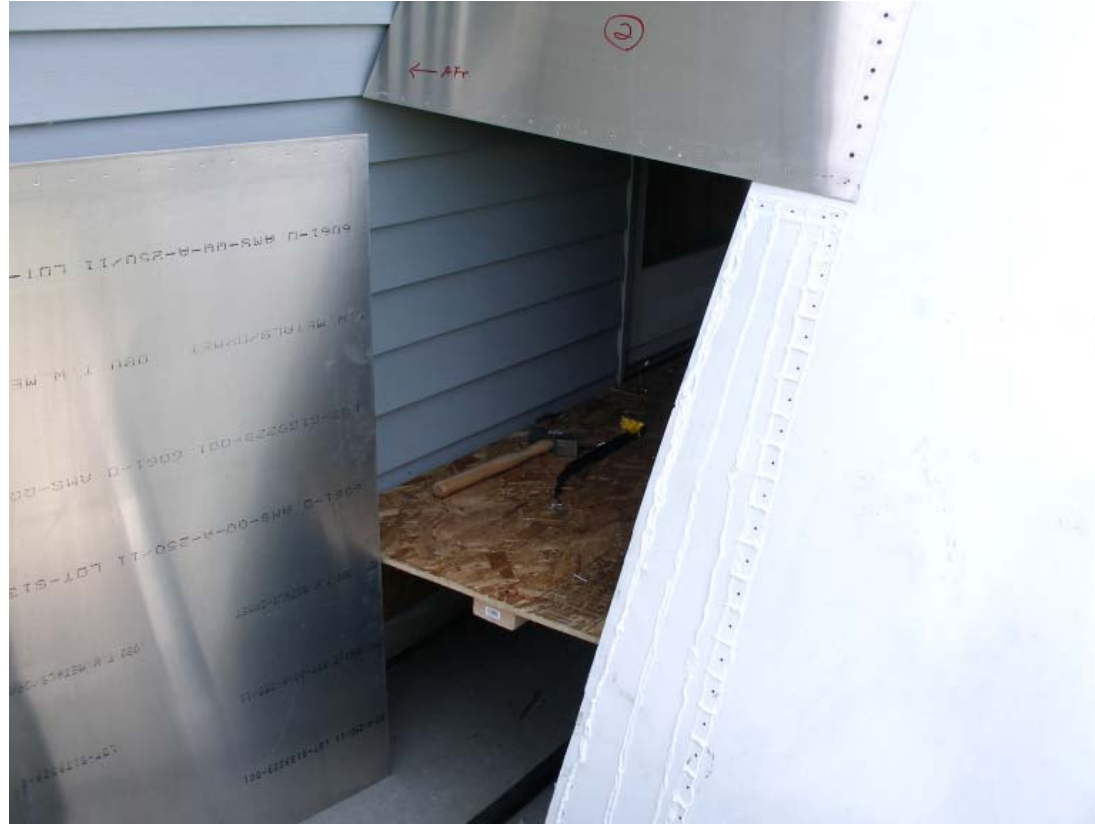
NORTH SIDE

- 1st. layer of ½” particle board was screwed to the top of the 2x4 structure
 - Additional layer of ½” plywood with bonded plastic top layer added later for additional strength and protection from any potential water leaks
- Aluminum sheet metal was added to extend the fuselage from the airframe to the house. Weight of this metal is supported exclusively by the 747. No screws penetrated the vinyl siding
 - UV resistant foam pipe insulation closed the gap between the sheet metal and vinyl siding
- All sheet metal was screwed into the airframe for easy removal when the cockpit was relocated into a new garage
- Sheet metal was caulked to prevent water intrusion

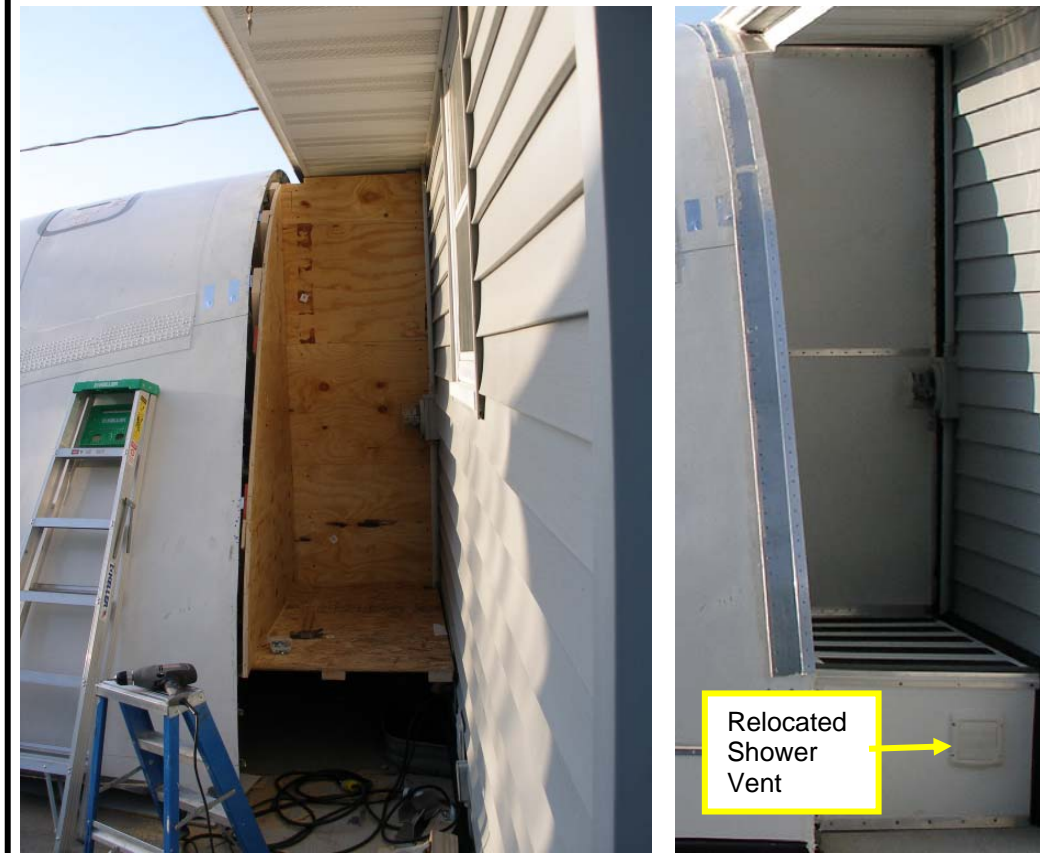
SOUTH SIDE

- To provide continued access to the electric meter, a wall was created with 1” plywood and 2x4s primarily affixed to the 747 fuselage and bottom platform
- Only ONE screw was required to be driven through the roof overhang as an anchor point for the upper right hand corner of the wall. The rest was screwed in via multiple L brackets
 - UV resistant foam pipe insulation was used to close the gap between the wall and siding – no screws through the siding were required
 - Strips of rubber were used to close the gap between the roof overhang and wall. No screws were required.
- Aluminum sheet metal closed the gap between the cut fuselage skin and new rear wall.
- Plastic sheets are retained by metal strips that are pre-caulked and screwed in to provide a water-tight seal in this area

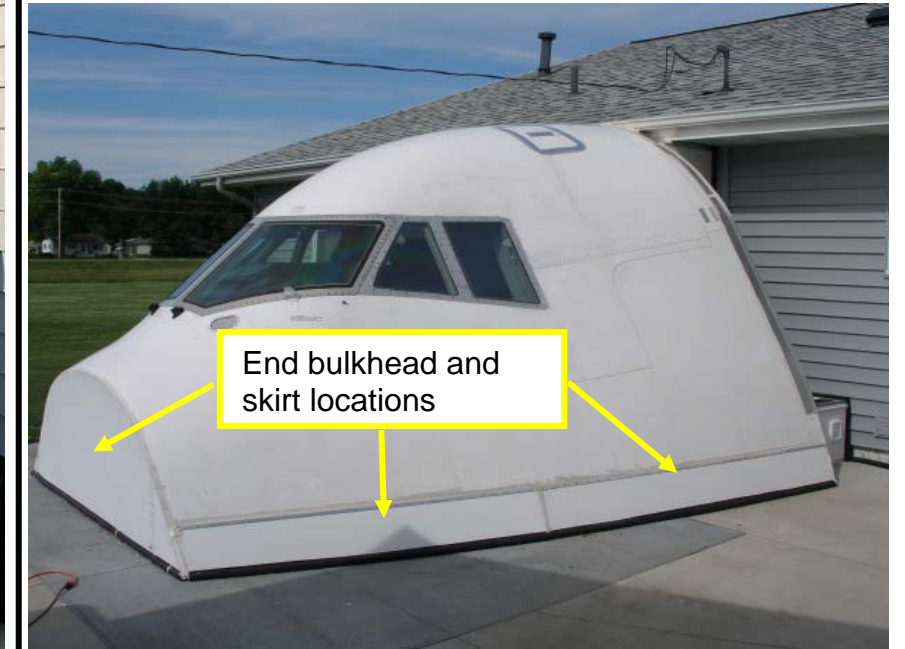
- A plastic “skirt” was placed over the cut skin under the cockpit with UV-resistant foam rubber pipe insulation between the concrete and plastic. This provided the following:
 - Covers all sharp cut edges on the fuselage
 - Prevents small animals from getting under the cockpit and nesting
 - The skirt does not prevent insect and water intrusion on concrete, nor was it intended to
- A plywood bulkhead was added to the cut front end section to cover any sharp edges and prevent animal entry beneath the cockpit
- Extensive use of caulk was employed to seal all seams and joints at every area that had a gap
 - This excludes the home’s siding as caulk would be very difficult to remove from the vinyl. Caulk was used in the gutter area

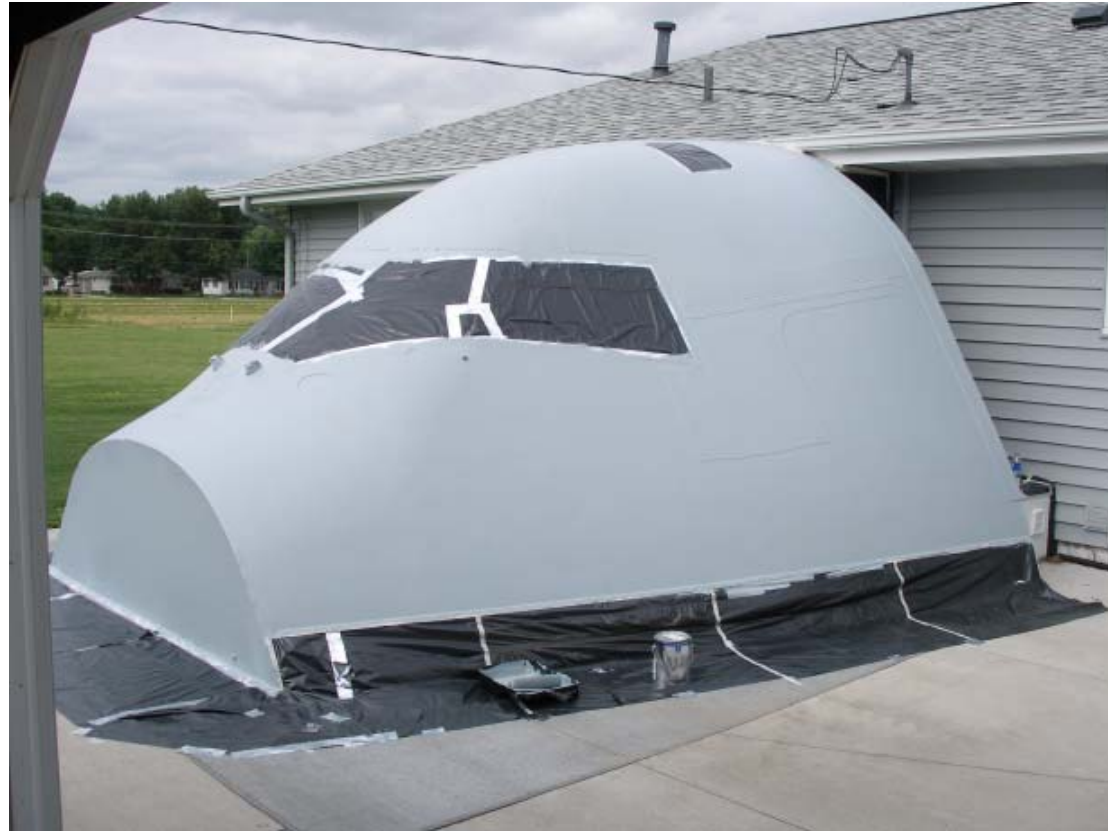
Masking & painting prep

- The cockpit was masked and repainted the same color as the house to prevent the blinding contrast of the original all-white paint and the house
- When the cockpit is relocated into a garage, this paint will be removed and the fuselage repainted with a proper glossy finish

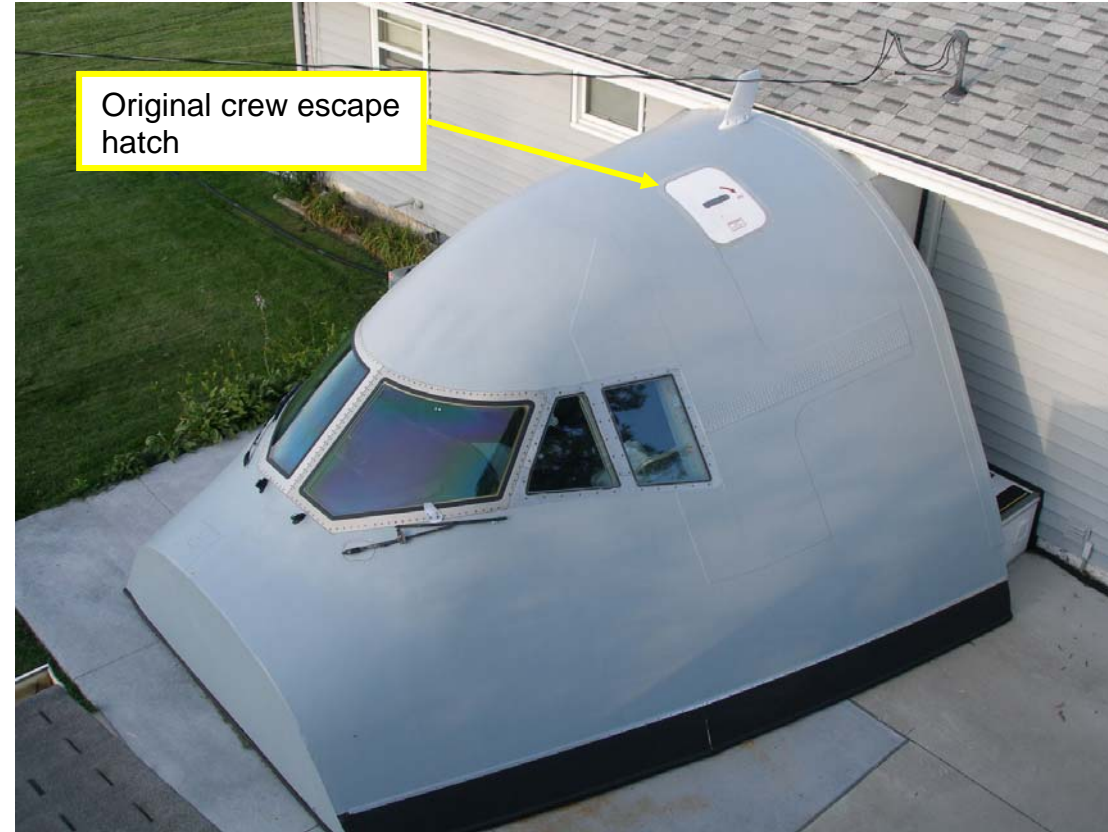
Completed exterior preservation work

- The primary way into the cockpit is through the sliding glass patio doors in the kitchen
- An emergency exit hatch, which is fully operational, is located on the cockpit roof

- None of the cockpit windows can be opened
- All windows are thick, multi-layered panels with several layers used for window heating, which is typically unnecessary where it stands now

- During extremely cold weather over a period of a week or more, some windows sections will fog internally, thus requiring temporary activation of integral window heating to clear them up. Window heating required 115VAC @ 15 amps for each of the pilot windows. 115V @ 7.5 amps was required for each side window. The side windows had pre-existing heat sensing switches that regulated the glass temperature. The main windshields had a complex heat sensing system that was bypassed and glass temperature was monitored by touching the glass.

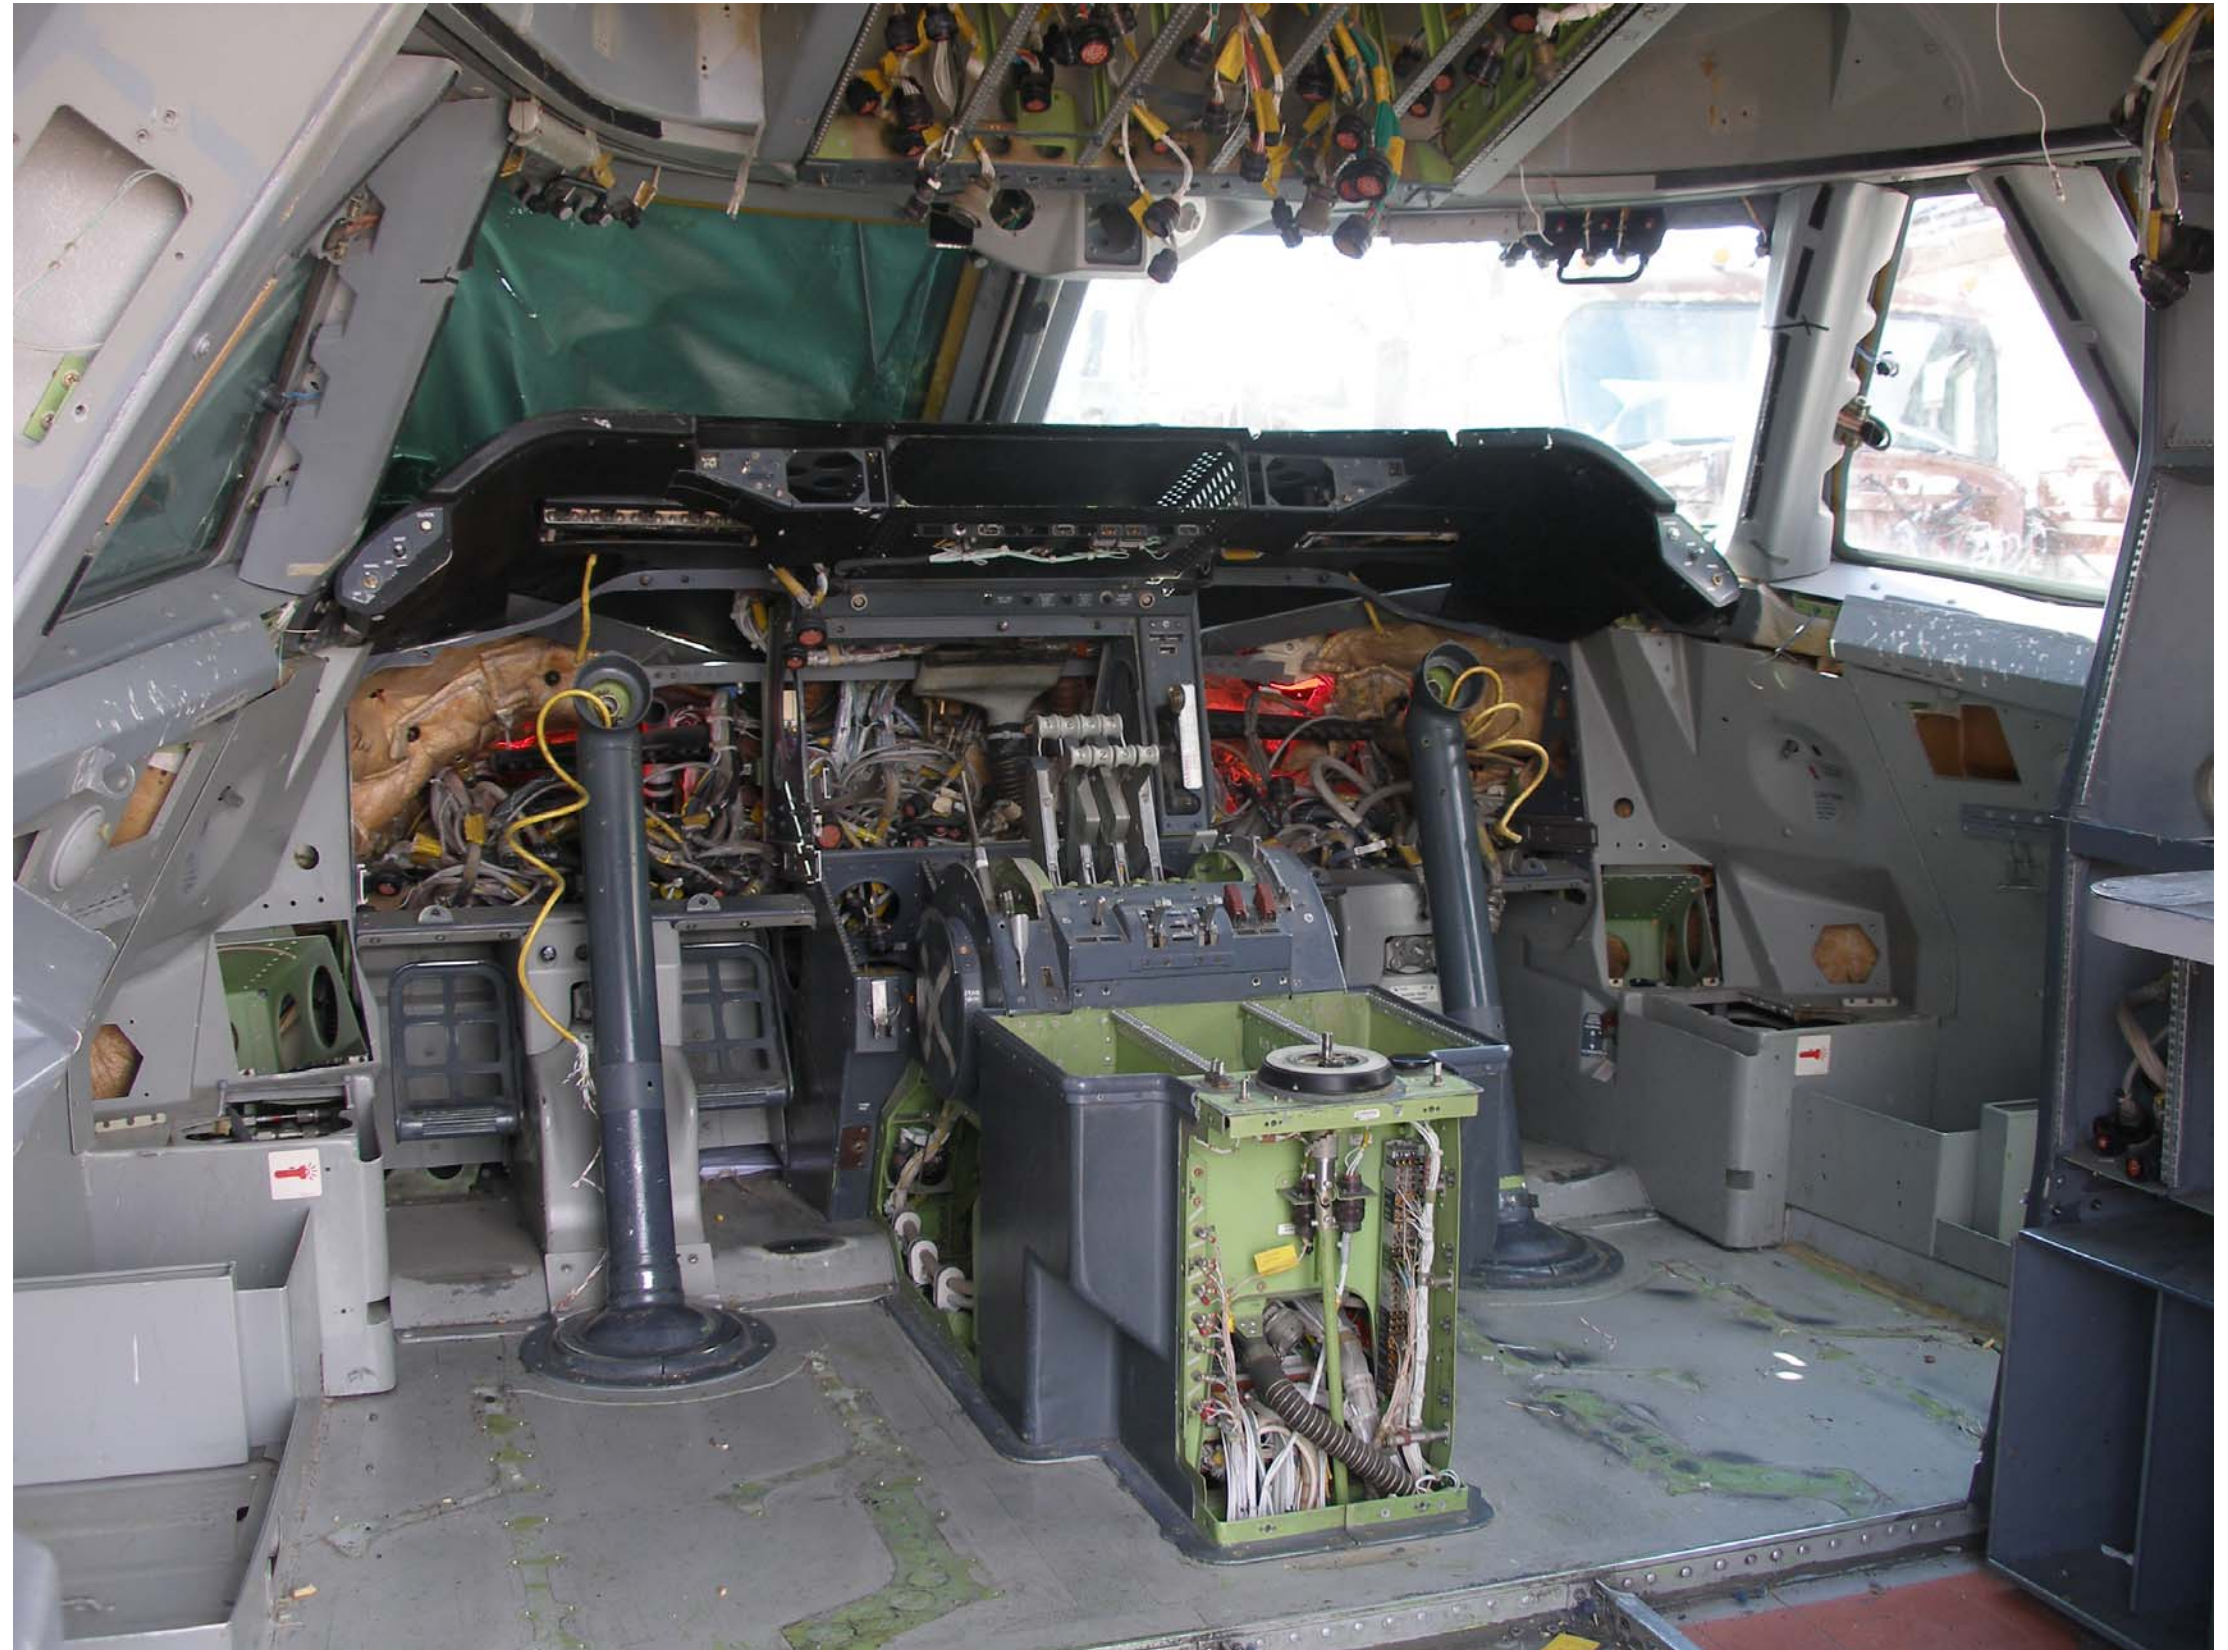
As all airliner cockpits endure a lot of wear & tear, there was a tremendous amount of restoration work to be done. The entire interior had to be removed, along with all of the wiring. Luckily, since it lived most of its life as a cargo aircraft, there was no evidence of nicotine stains covering every surface. The air circulation system in passenger aircraft before smoking was banned, would spread a thick film of nicotine on just about every surface of the cockpit, especially behind control panels.

Its freighter status did not exempt it from coffee spillage, though. At every crew position, a large amount of dried coffee had to be cleaned up behind wall trim, under panels, and even out of wiring bundles, relay cases and power transformers.

Sloppy paint touch-ups, patches and crack repairs all had to be cleaned up and redone properly. The “finger cheese” coating on every lever, switch and knob had to be cleaned with Formula 409 and a toothbrush, all air duct tubing had to be removed and replaced with fresh aerospace ducting, air gaspers had to be disassembled and cleaned, Velcro strips attached with aggressive glue had to be removed from cockpit surfaces without damaging the material beneath. All decals had to be carefully removed and cleaned for eventual re-use, or replaced altogether. Strong solvents such as Acetone, Naptha and alcohol were required to clean many surfaces in preparation of repainting. Every single part removed had to be carefully cleaned/repainted, replaced or stored for eventual reinstallation. Luckily the cockpit windows were in perfect condition with no scratches, delamination or cracks.

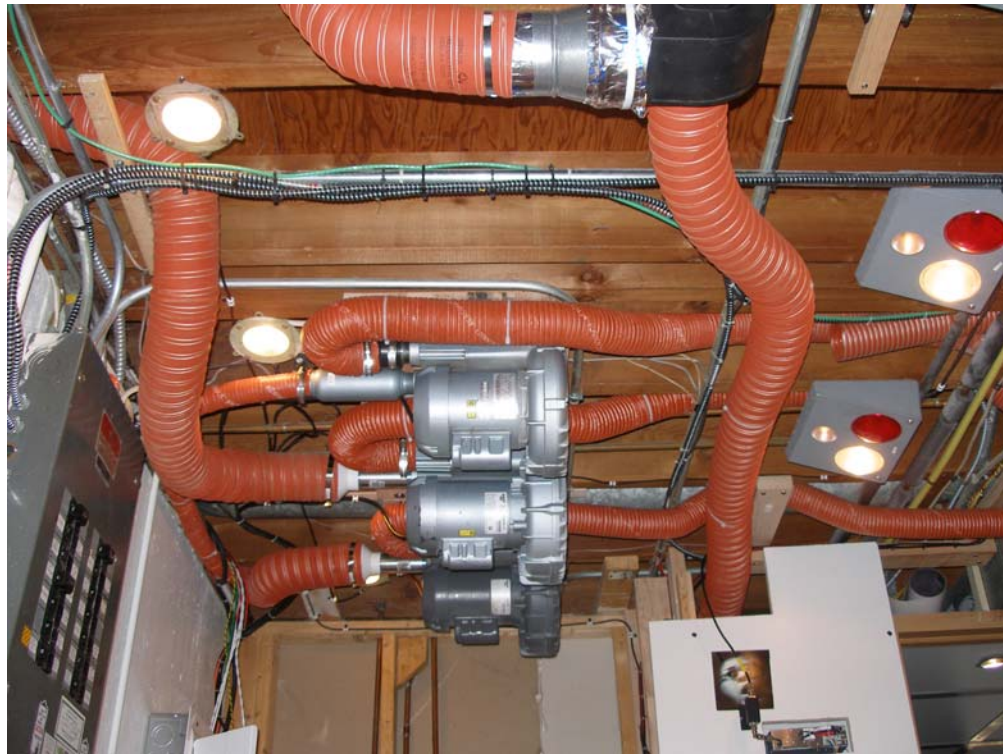
Three regenerative high capacity blowers were mounted to the Ceiling and drew air from the house's air conditioning ductwork out to The flight deck's original complex ductwork and plenum system inputs

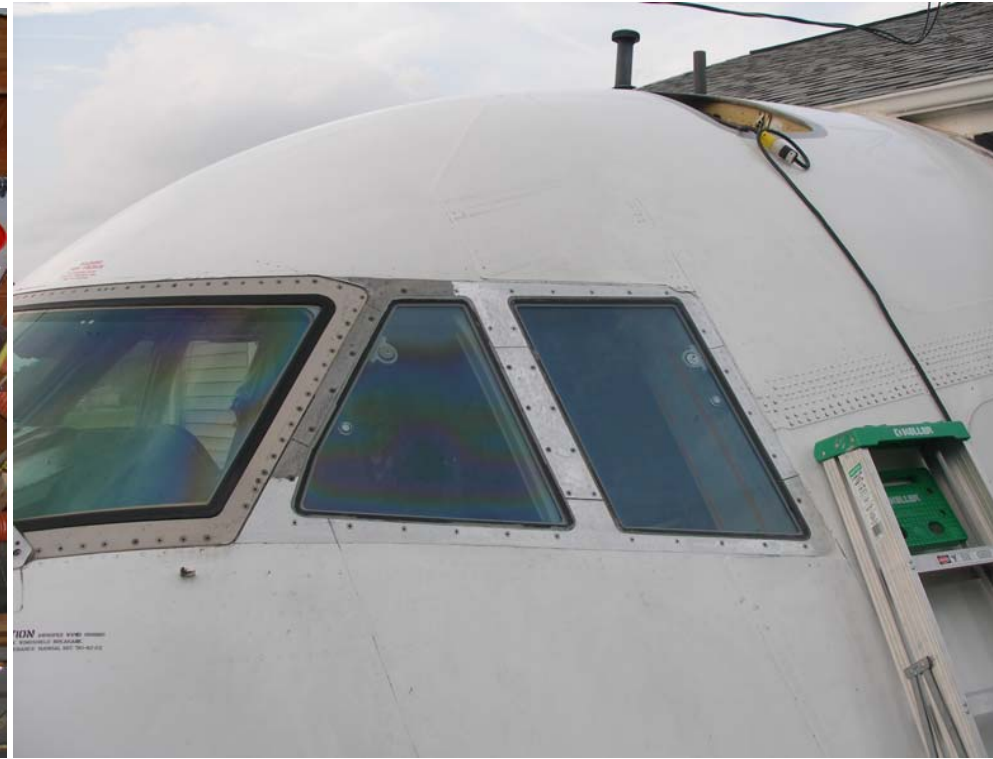
Very little restoration was required on the exterior before painting except the polishing the grime off of the aluminum side window frames

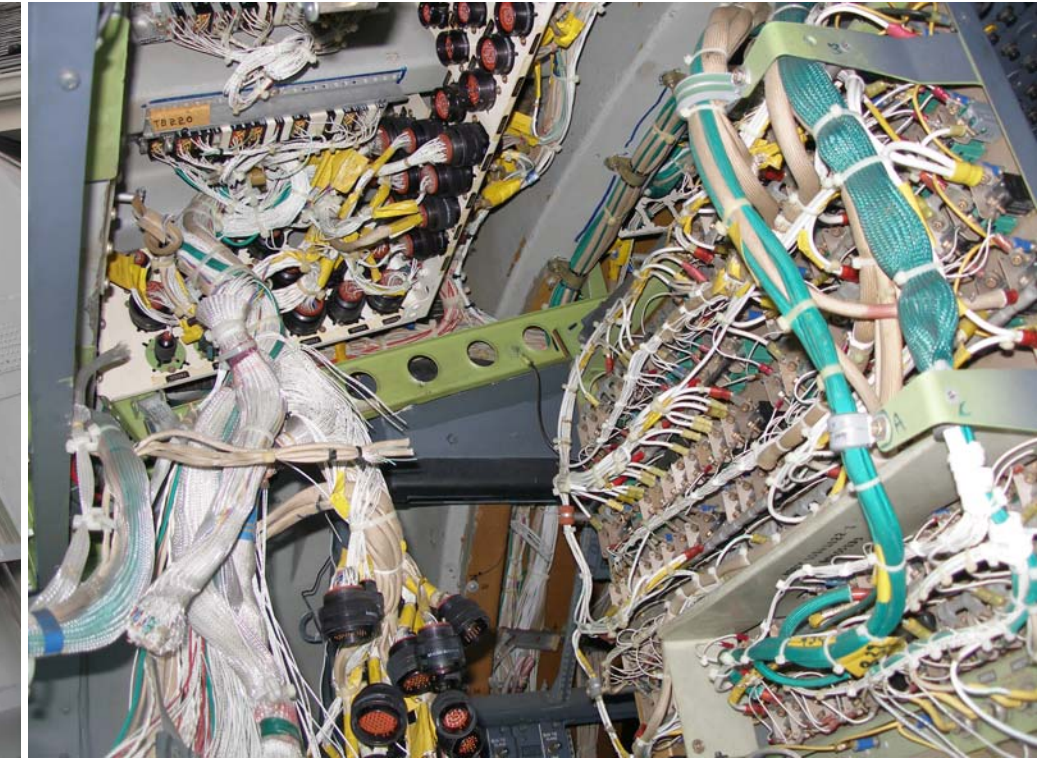
Behind every panel lied thousands of wires that had to be removed and connectors de-pinned and cleaned for eventual reinstallation

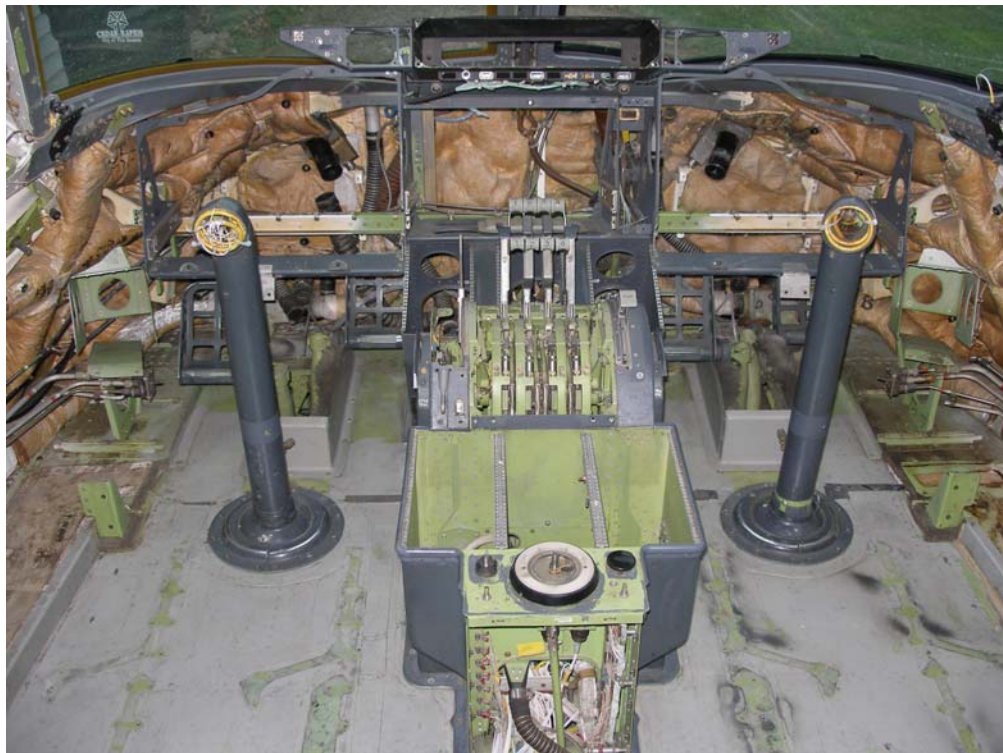
With glareshield and all wiring removed, access to the aeroduct tubing Could be gained and replaced and deep cleaning could finally begin

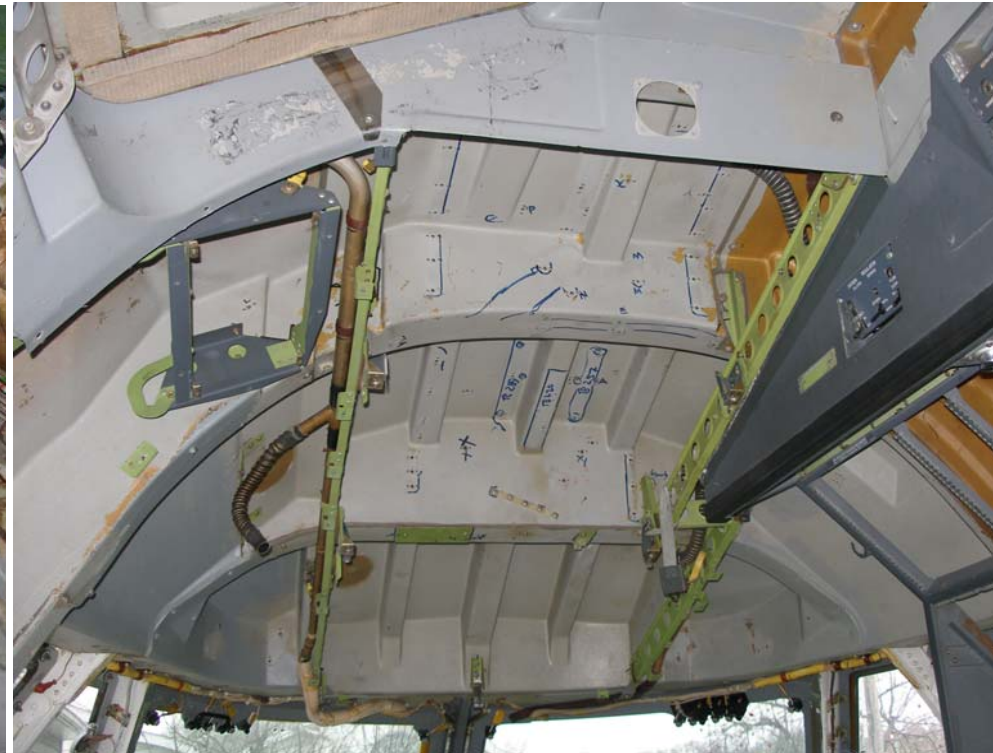
The removal of all the overhead wiring can be seen here now that the pilot's overhead panel and circuit breaker panels are removed.

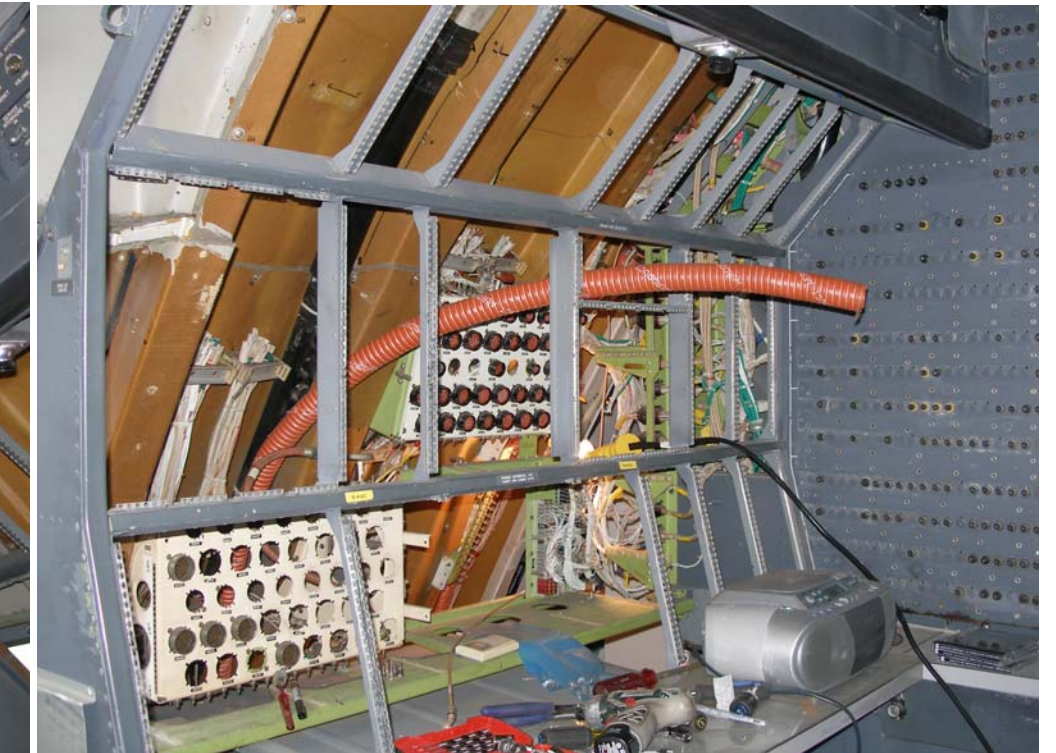
The Flight Engineer's station was especially time-consuming to de-wire
