Boeing 747-300 Cockpit Restoration Project Timeline & Development

For end use as a home flight simulator

Boeing 747-3H6, Serial number 23600, Total aircraft hours: 64141, Total cycles 13470, Last registration: B-KAC Dragonair Cargo, (Cathay Pacific) Hong Kong

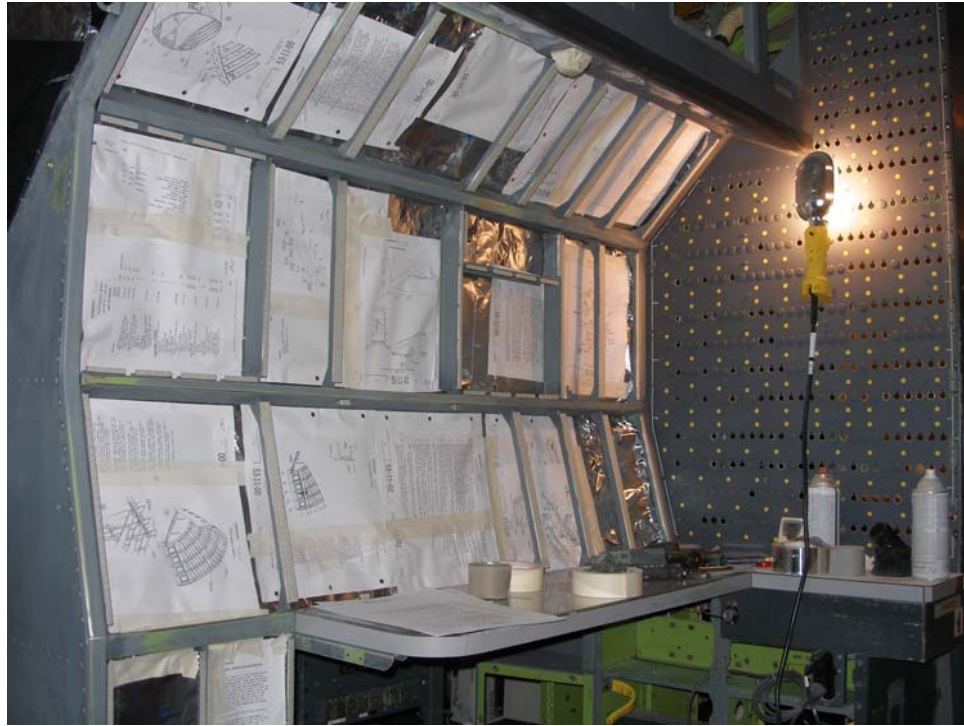
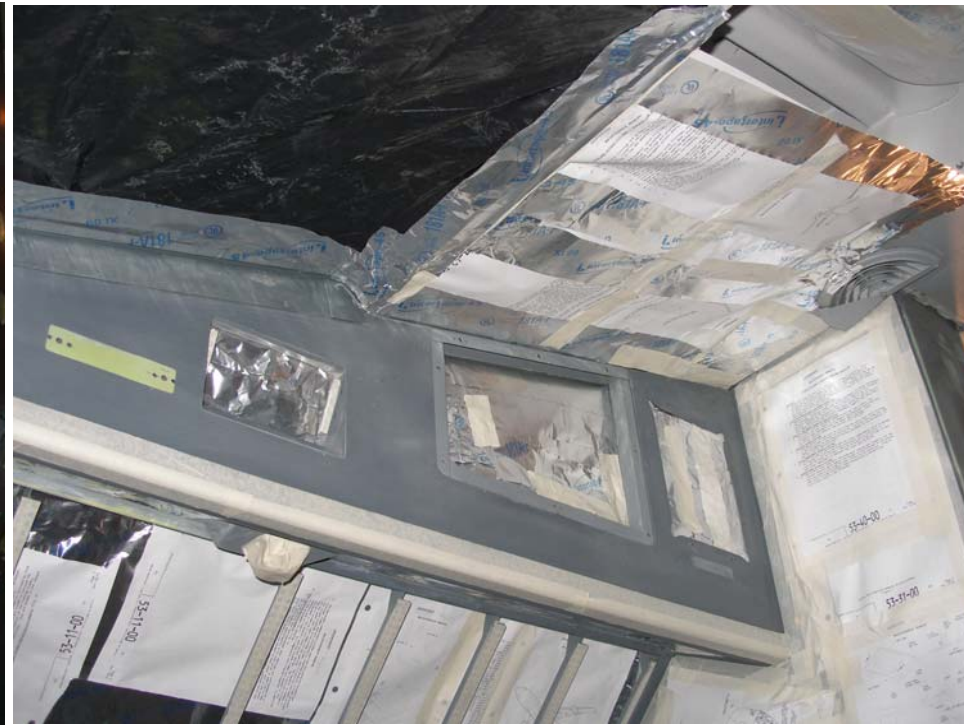
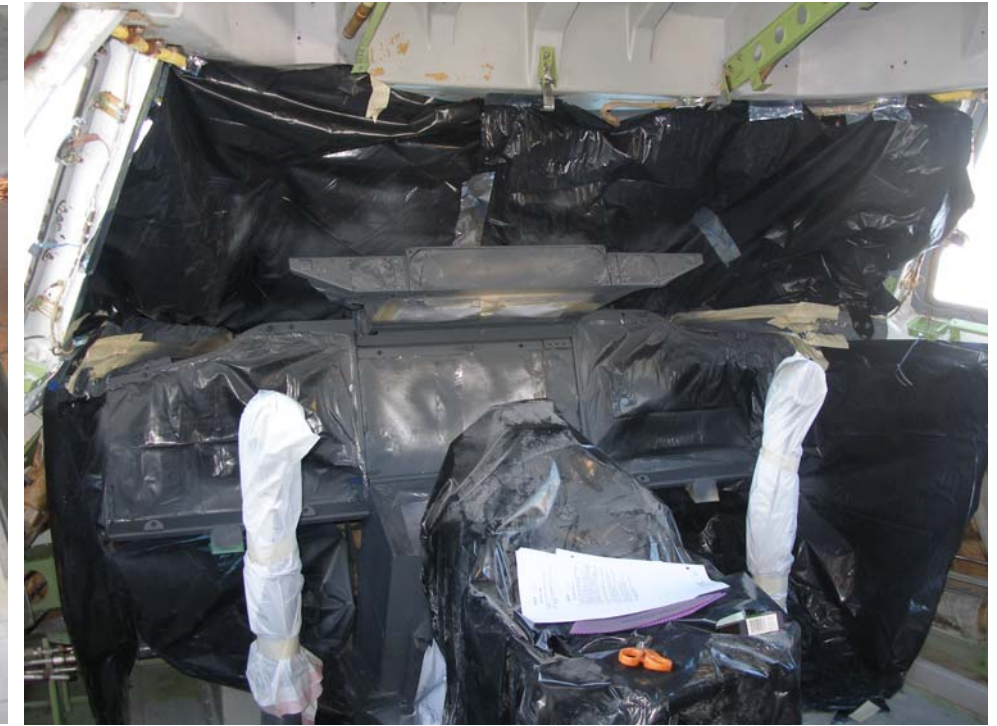
Precise masking was applied to every surface to be painted. No overspray was allowed into any area that did not already have factory gray paint. The spray paint used was custom-matched to Boeing gray

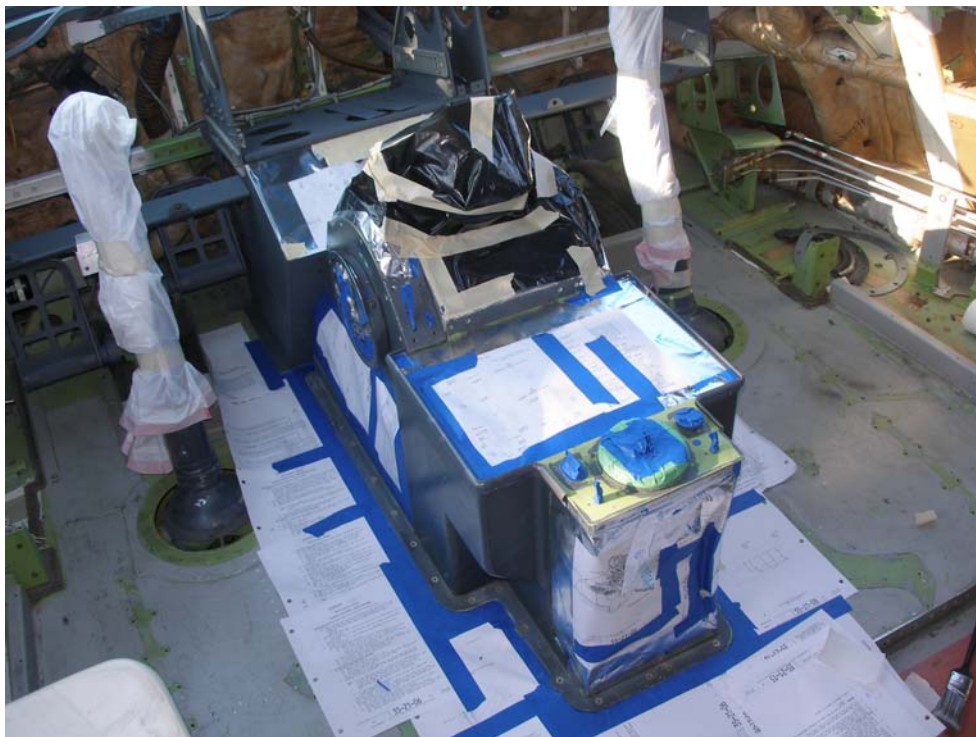
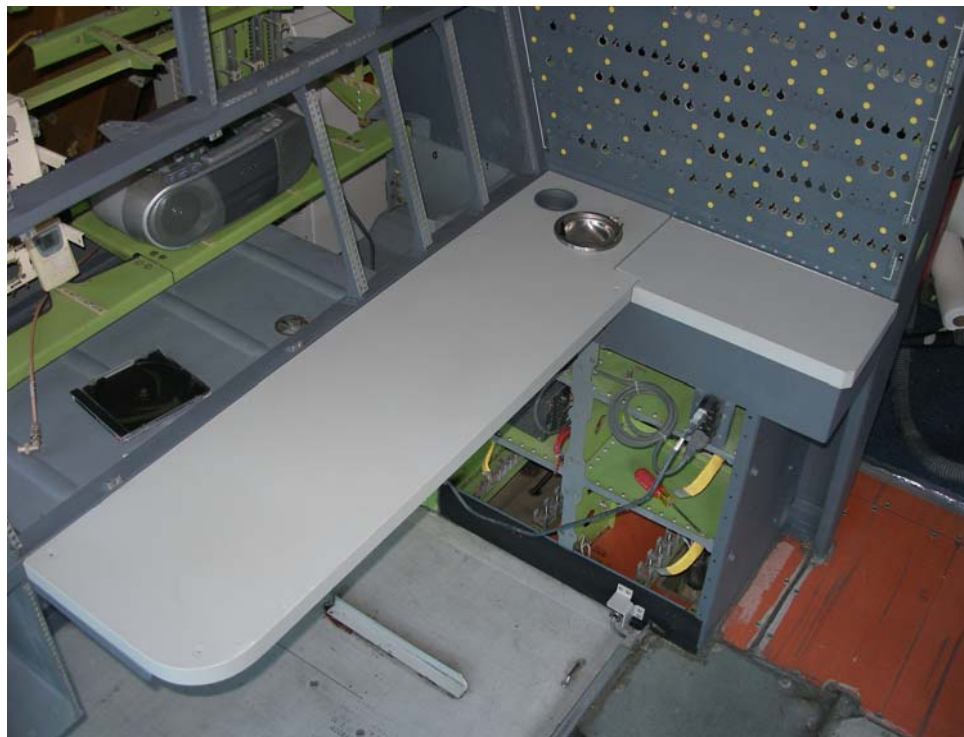
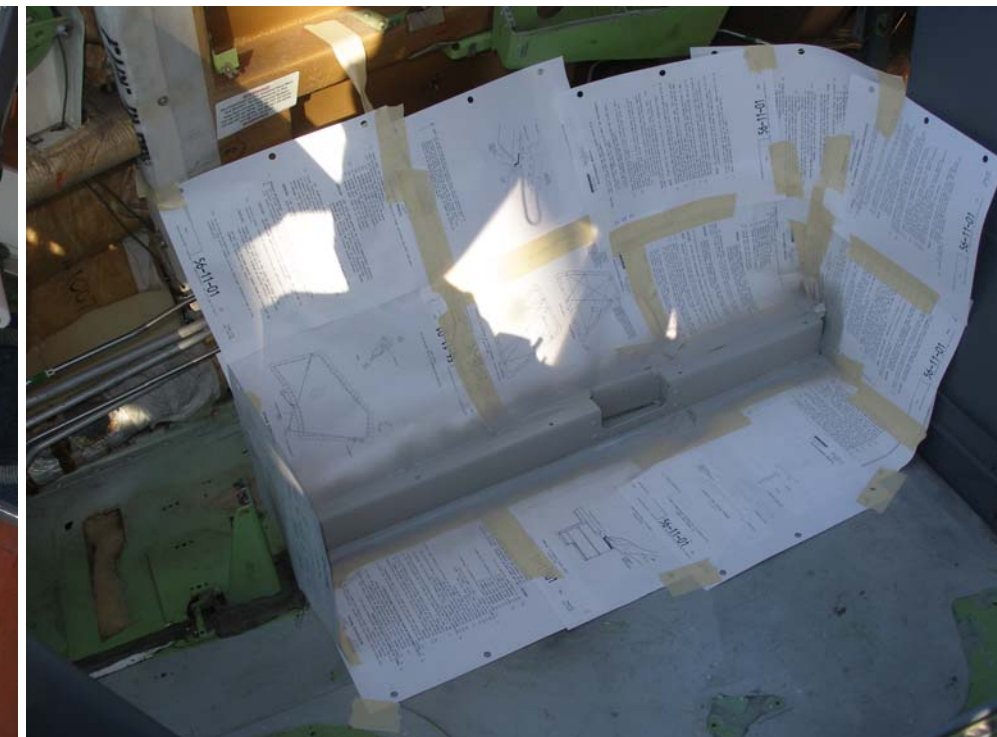
Masking and painting also included color-matched light gray spray paint, components of the cockpit. All removed interior walls and trim were restored and painted in the garage. Zinc chromate primer was used where sanding revealed bare metal. Black paint was applied in the few places where that color was required. Multiple coats of paint were patiently applied to ensure a drip-free, thick overall coat. In the case of circuit breaker panels, all breakers were removed and replaced with new aerospace circuit breakers. This made it easier to repaint the breaker panels and ensured the new panels were not populated with filthily and worn breaker buttons where the amperage reading could barely be seen.

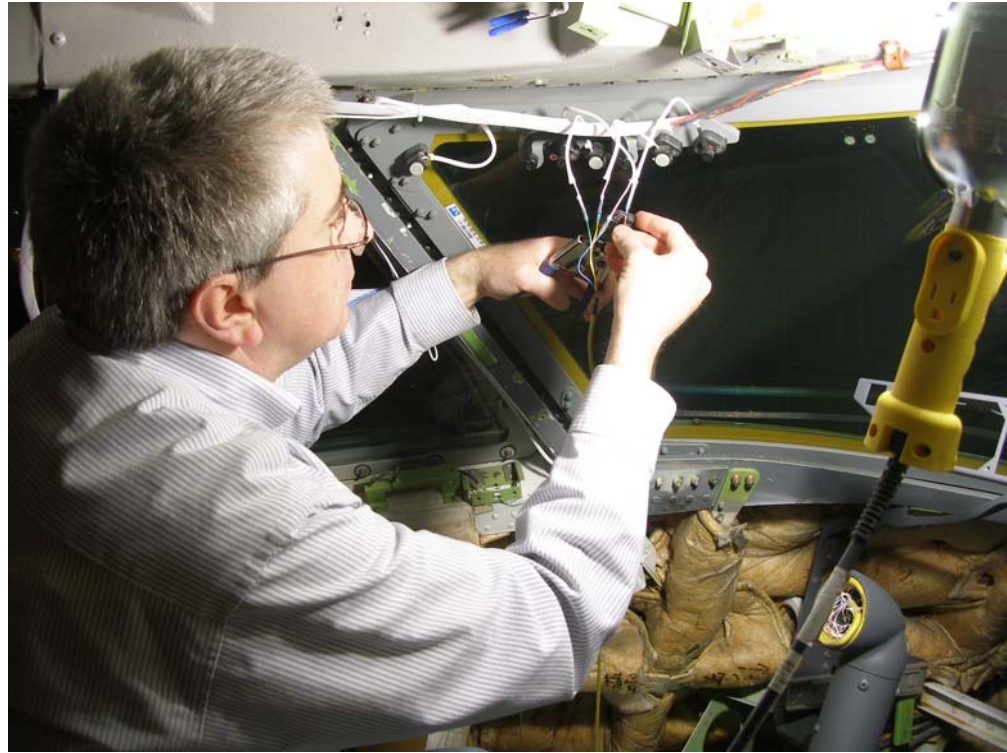
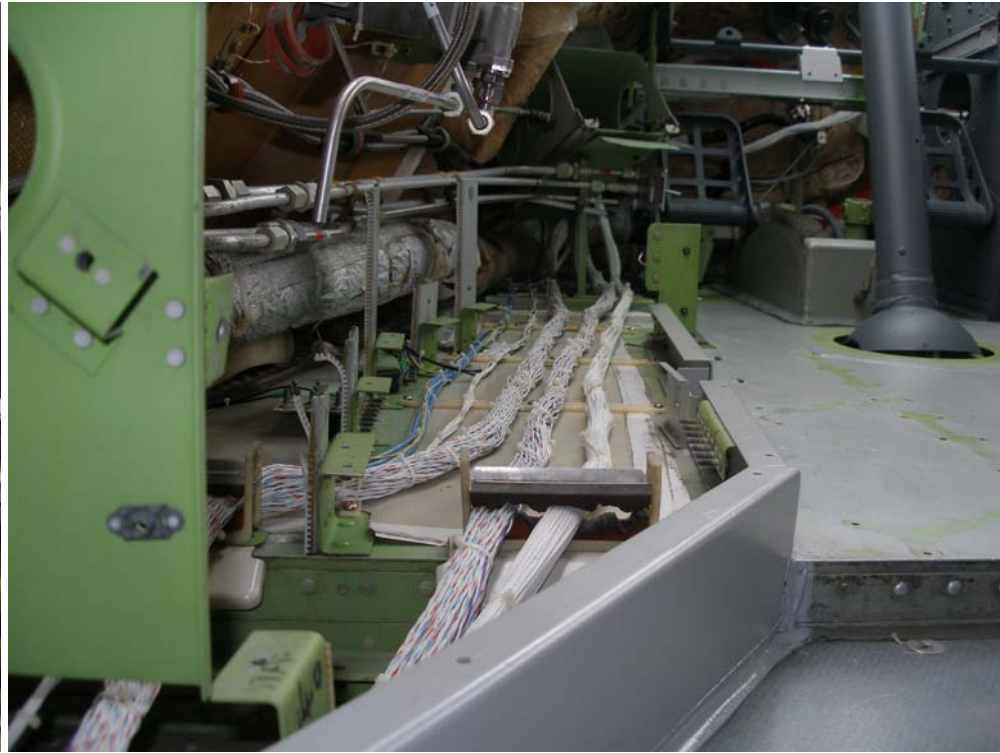
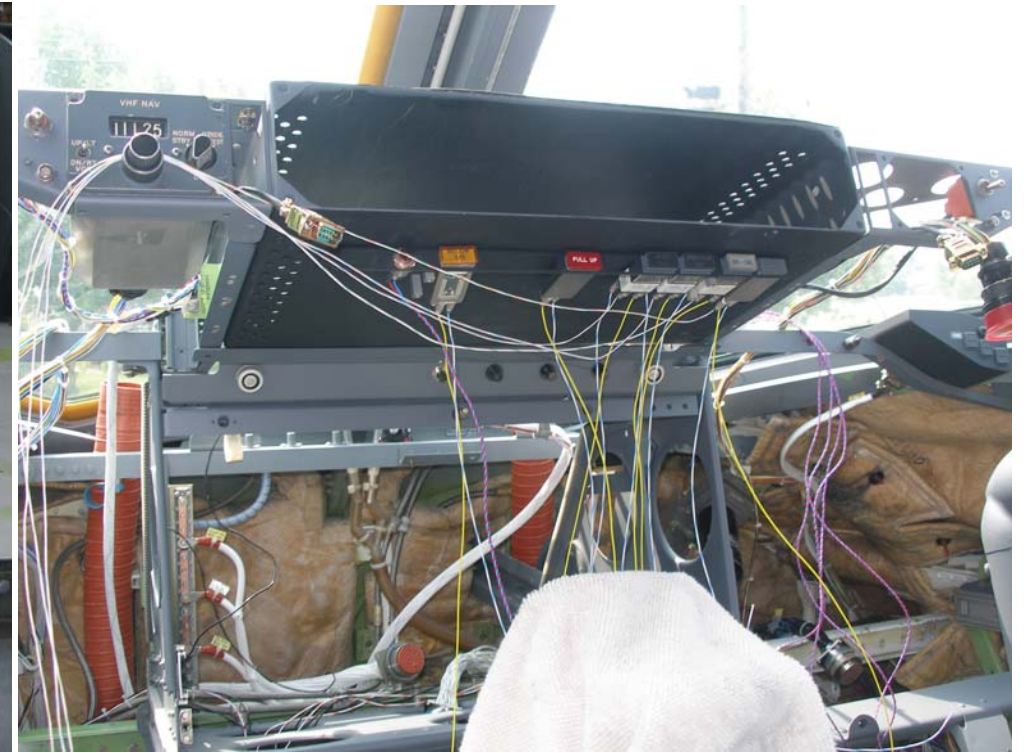
With all cleaning and painting finished, new wiring and air conditioning ductwork could be installed. Only aerospace wire and connectors were used for the refurbishment. All vent tubing was high temperature silicone covered fiberglass Aeroduct tubing. The original Boeing vent tubing was made of a black substance that dried out and created breaches for air leaks and allowed sediment to travel through the ducts and plenums. The silicone-based replacement tubing will not disintegrate into powder over the decades and is smoother on the outside, thus making it easier to slip through tight spaces. .

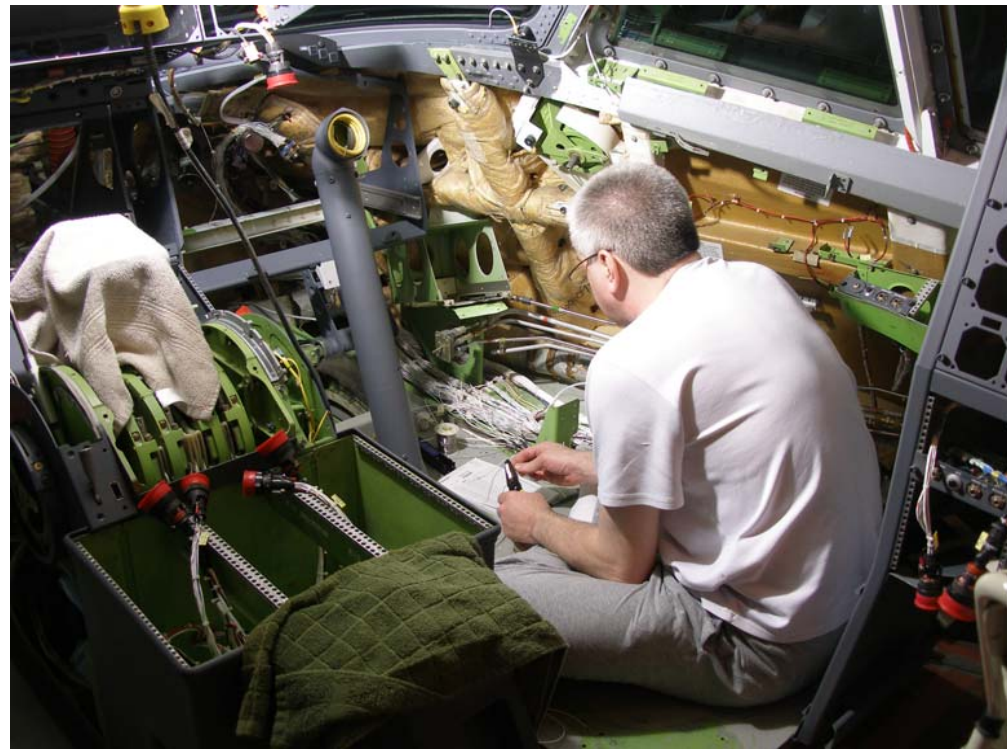
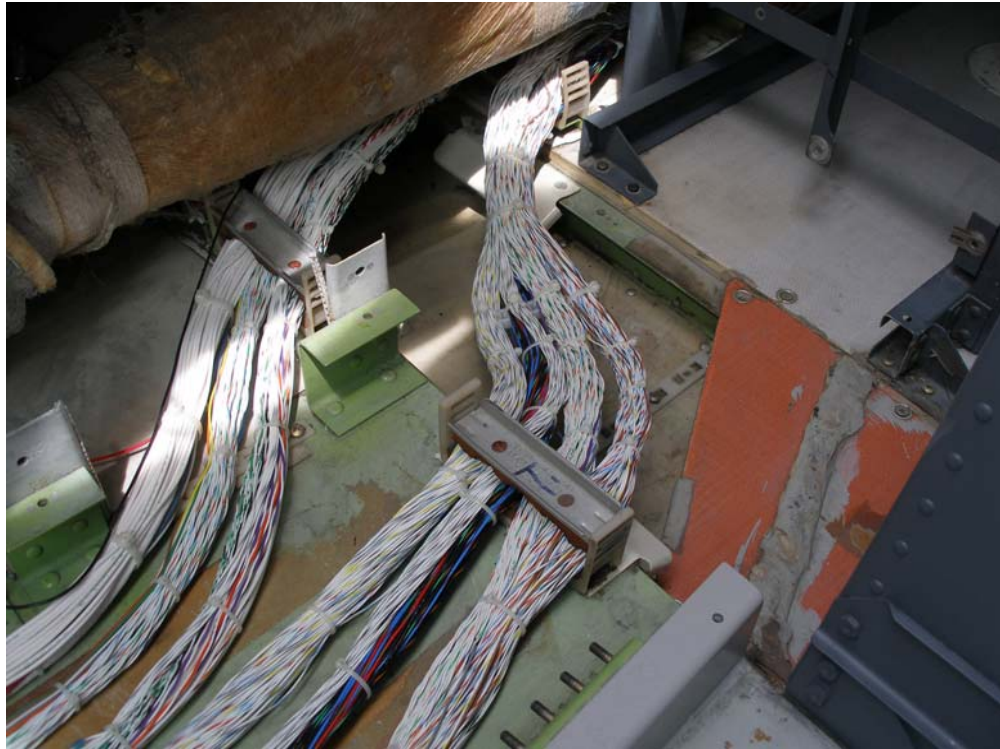
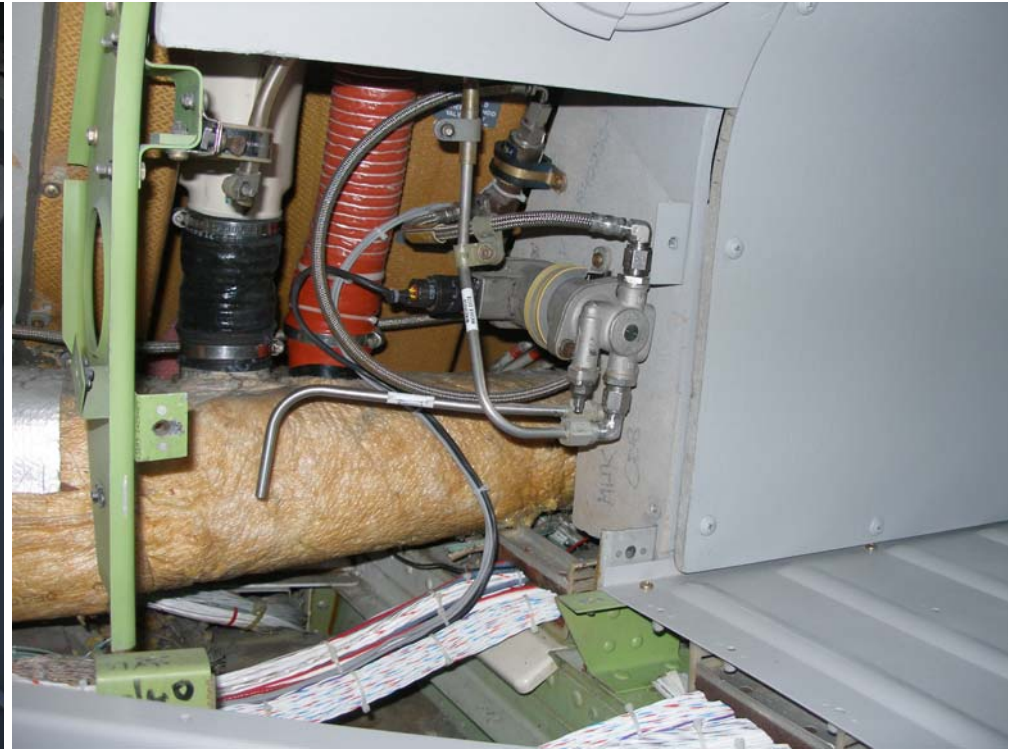
With the new main wire bundles created that lead from the front instrument panel to the rear of the flight deck, smaller wiring requirements were addressed. This included interior lighting, control yoke, windshield washer pump, windshield wiper motors, window heating, speakers and various switches on the throttle pedestal. Tightening of ductwork was performed and the wall panels were gradually reinstalled.

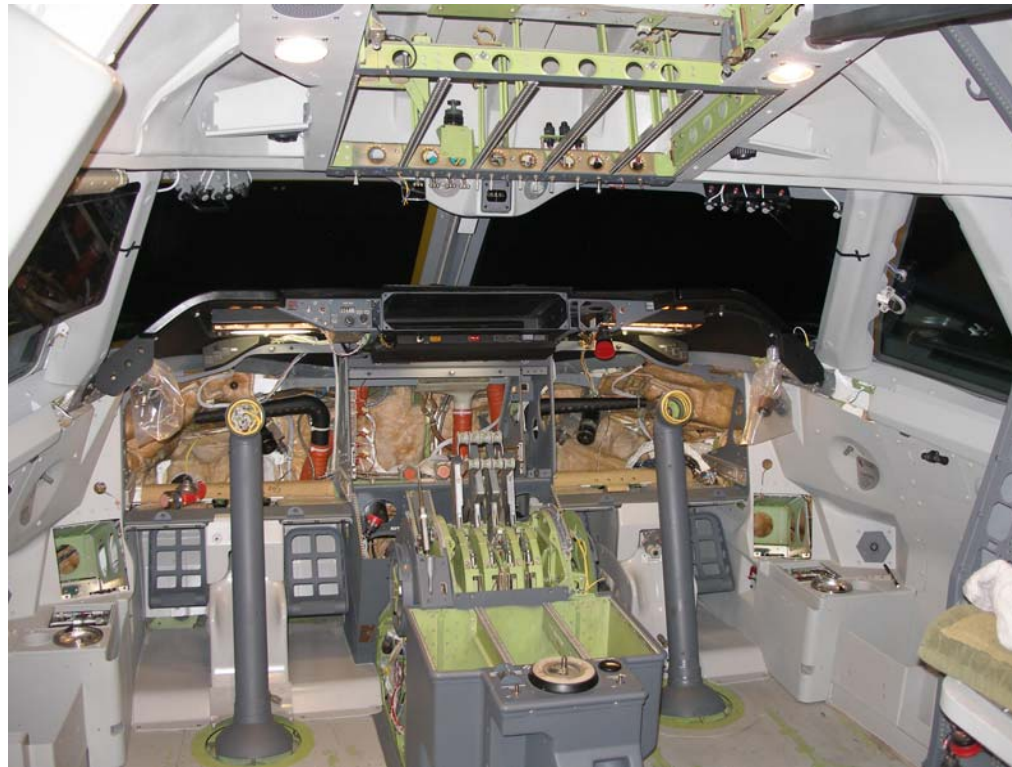
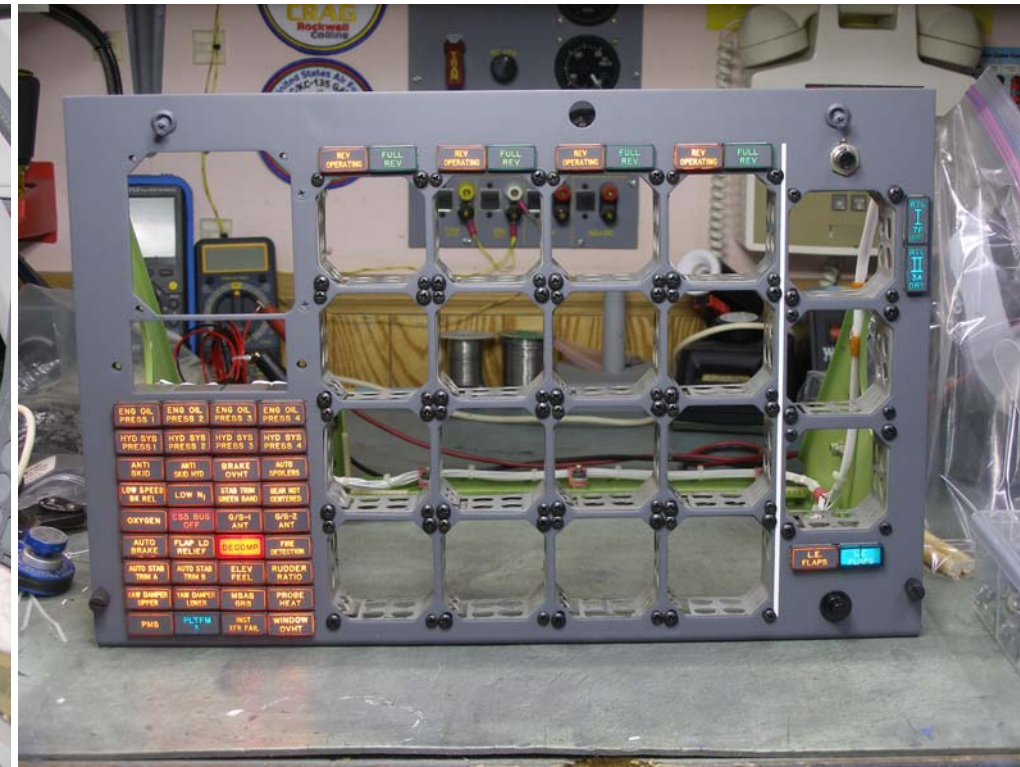
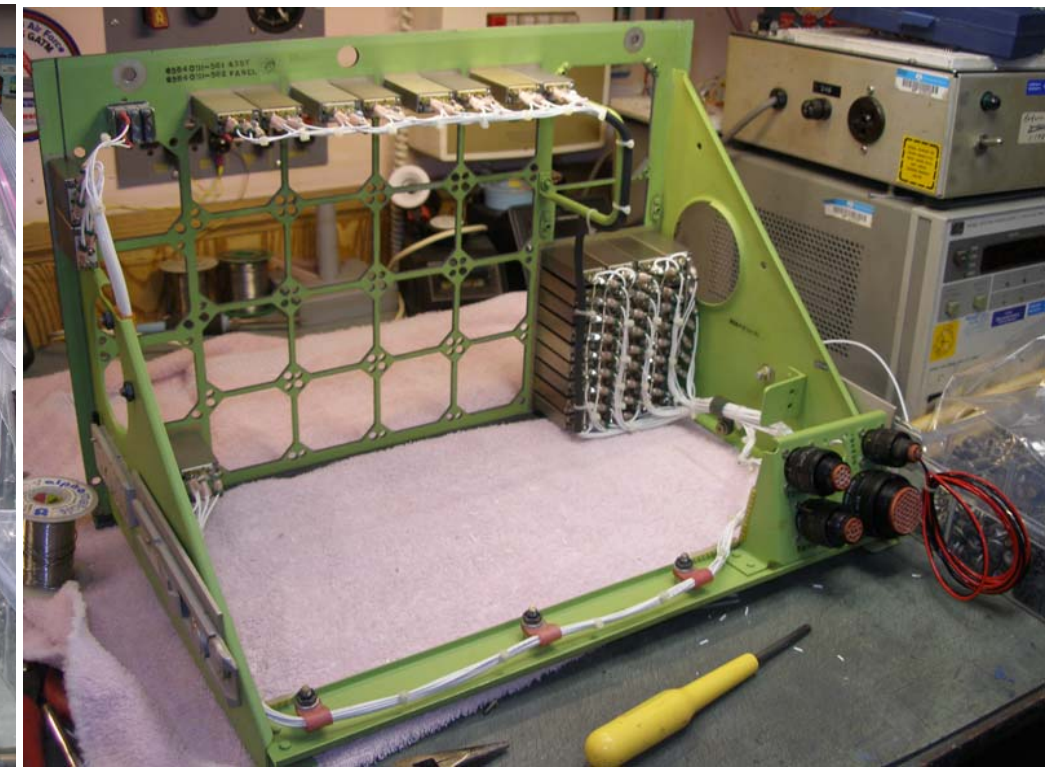
With the glareshield completely repainted, rewired and installed, the long process of refurbishing all of the flight deck's control panels was the next step. As with the cockpit itself, all panels were precision-masked after sanding and chemical treatments to prevent overspray into areas that should only show primer. The original panel cylindrical connectors were re-pinned with aerospace wire to aviation grade spade lug terminals that connect to the various lights and switches on each panel. Even the gauge clamps went through my dishwasher before being reattached to a panel with brand new black screws. Constant improvements are ongoing.

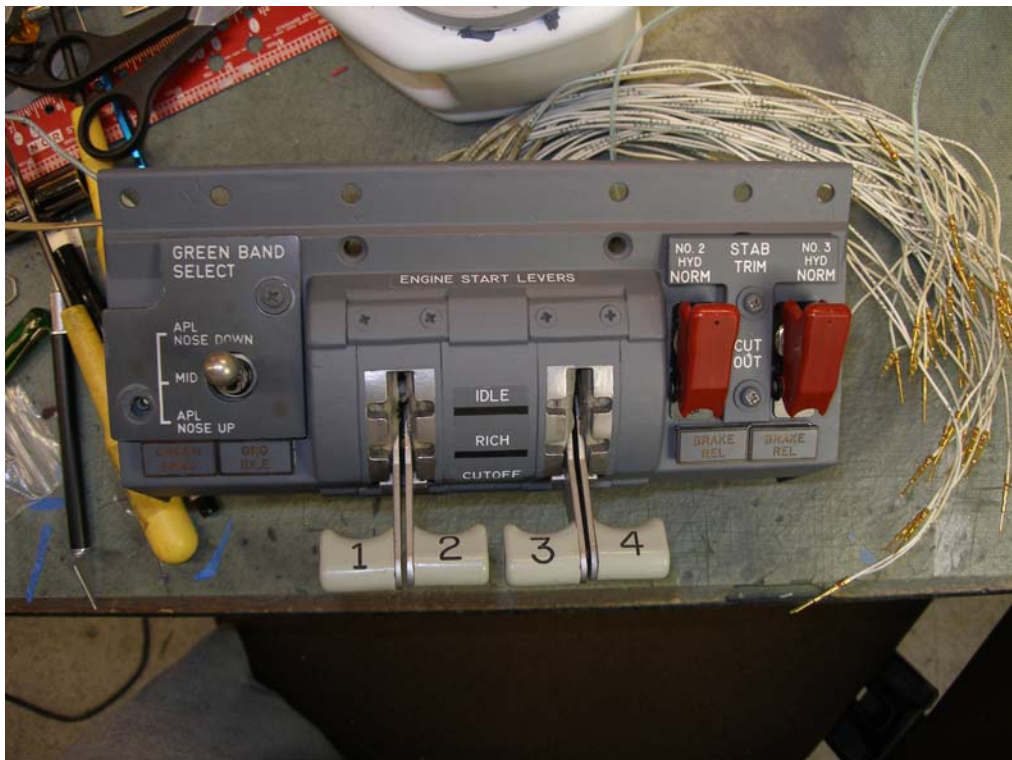
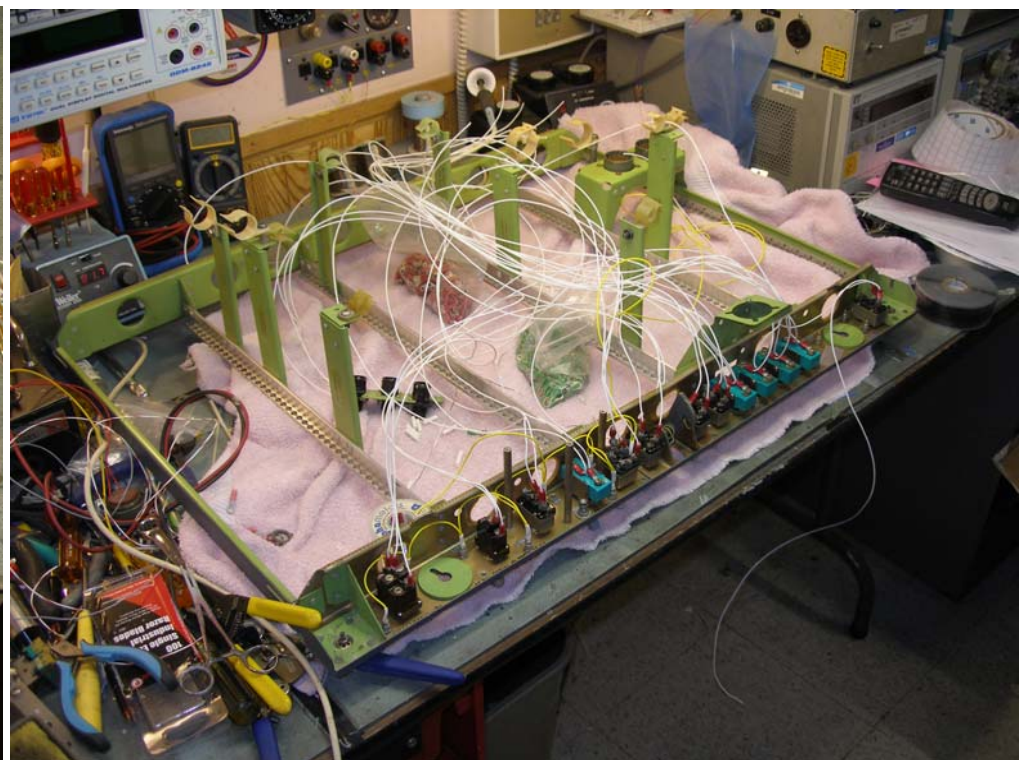
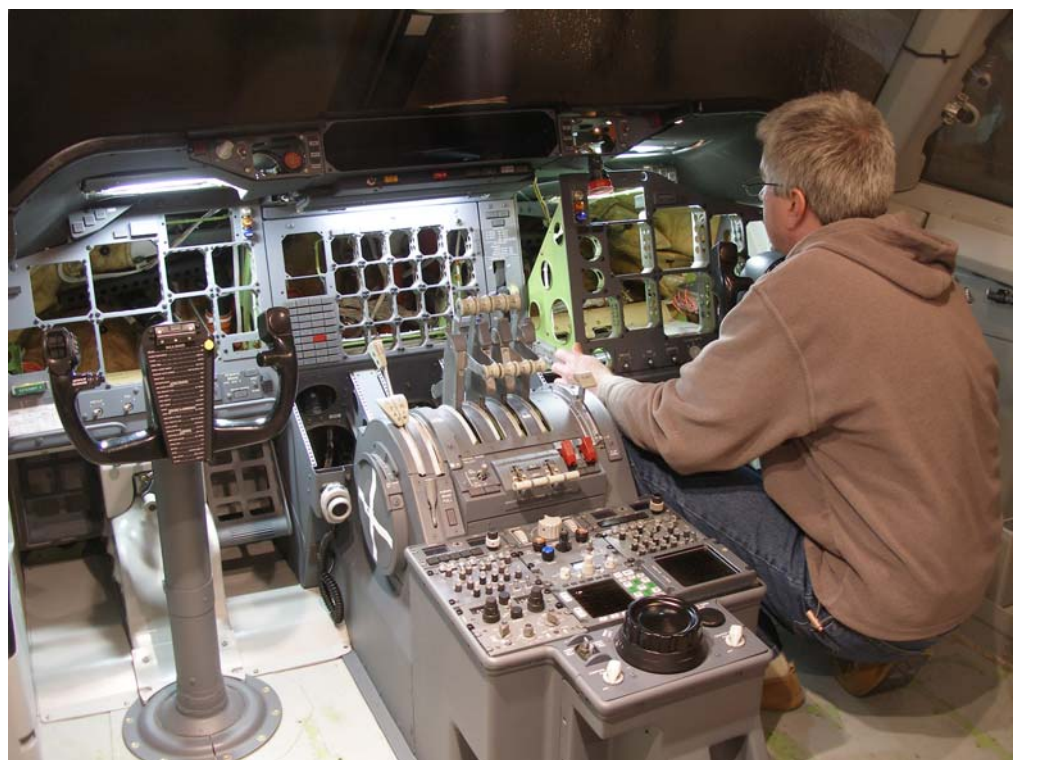
In many cases, multiples of the same panels and control heads had to be acquired to make one good panel. Edge-lit panel condition, white-tip toggle discolorations and any other faults had to be corrected.

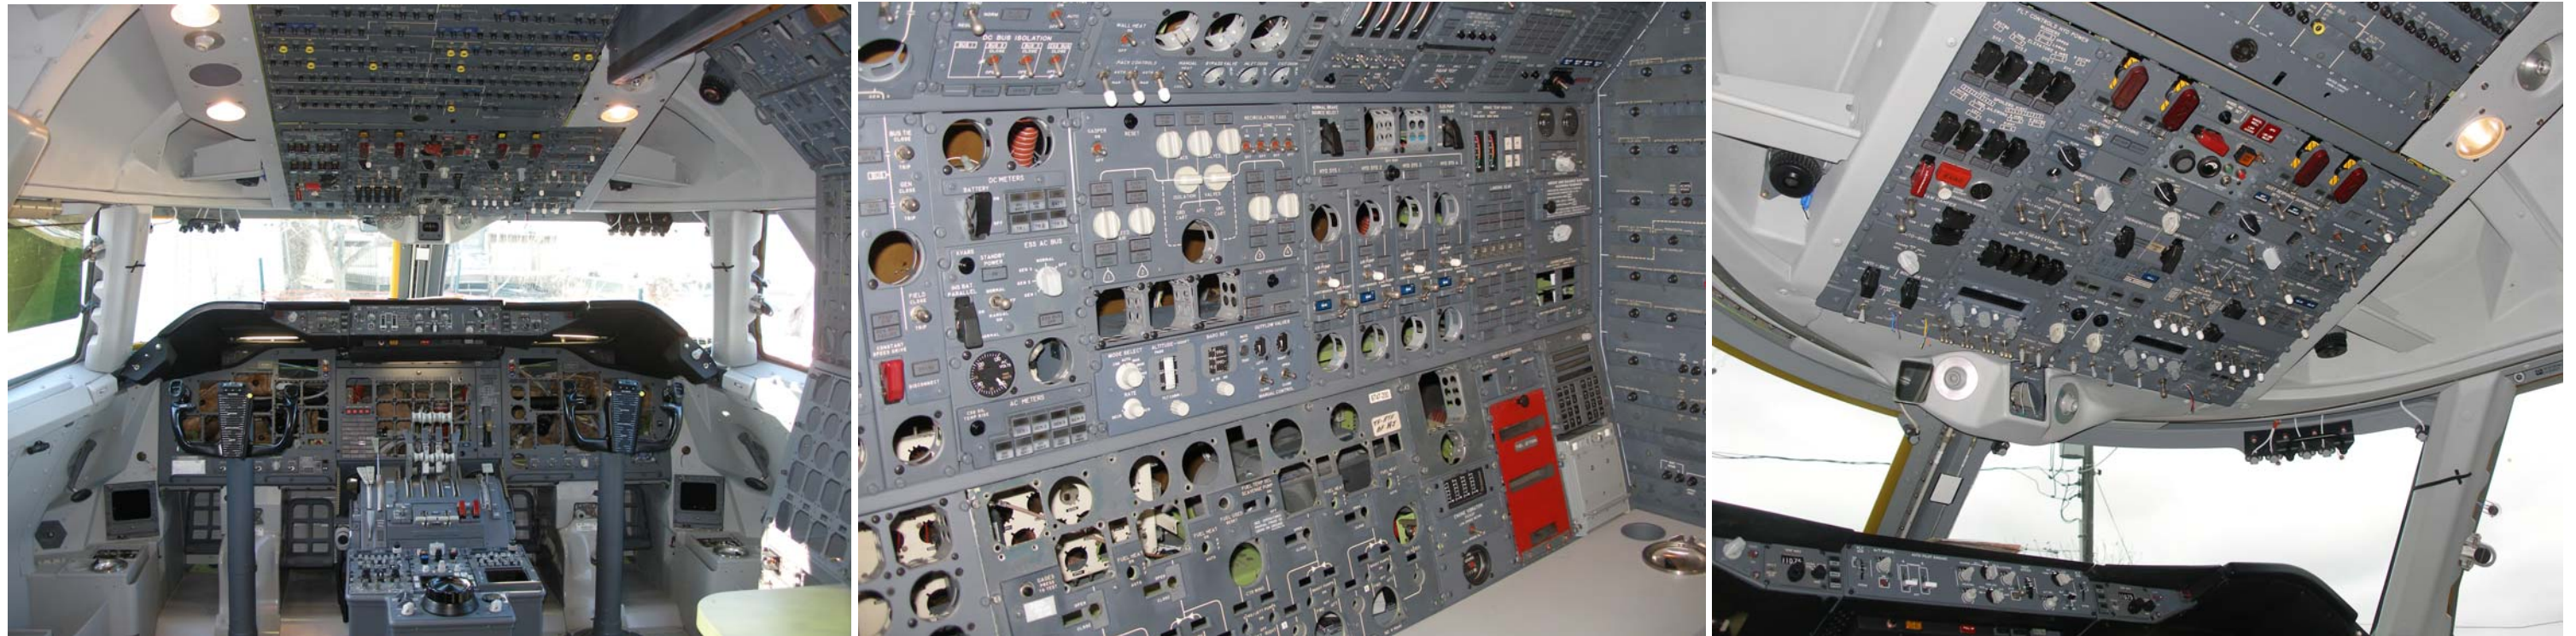
As each panel was restored, it was installed into its appropriate location. Again, multiple identical panels were required to assemble single panels that showed minimal wear. This process is ongoing.

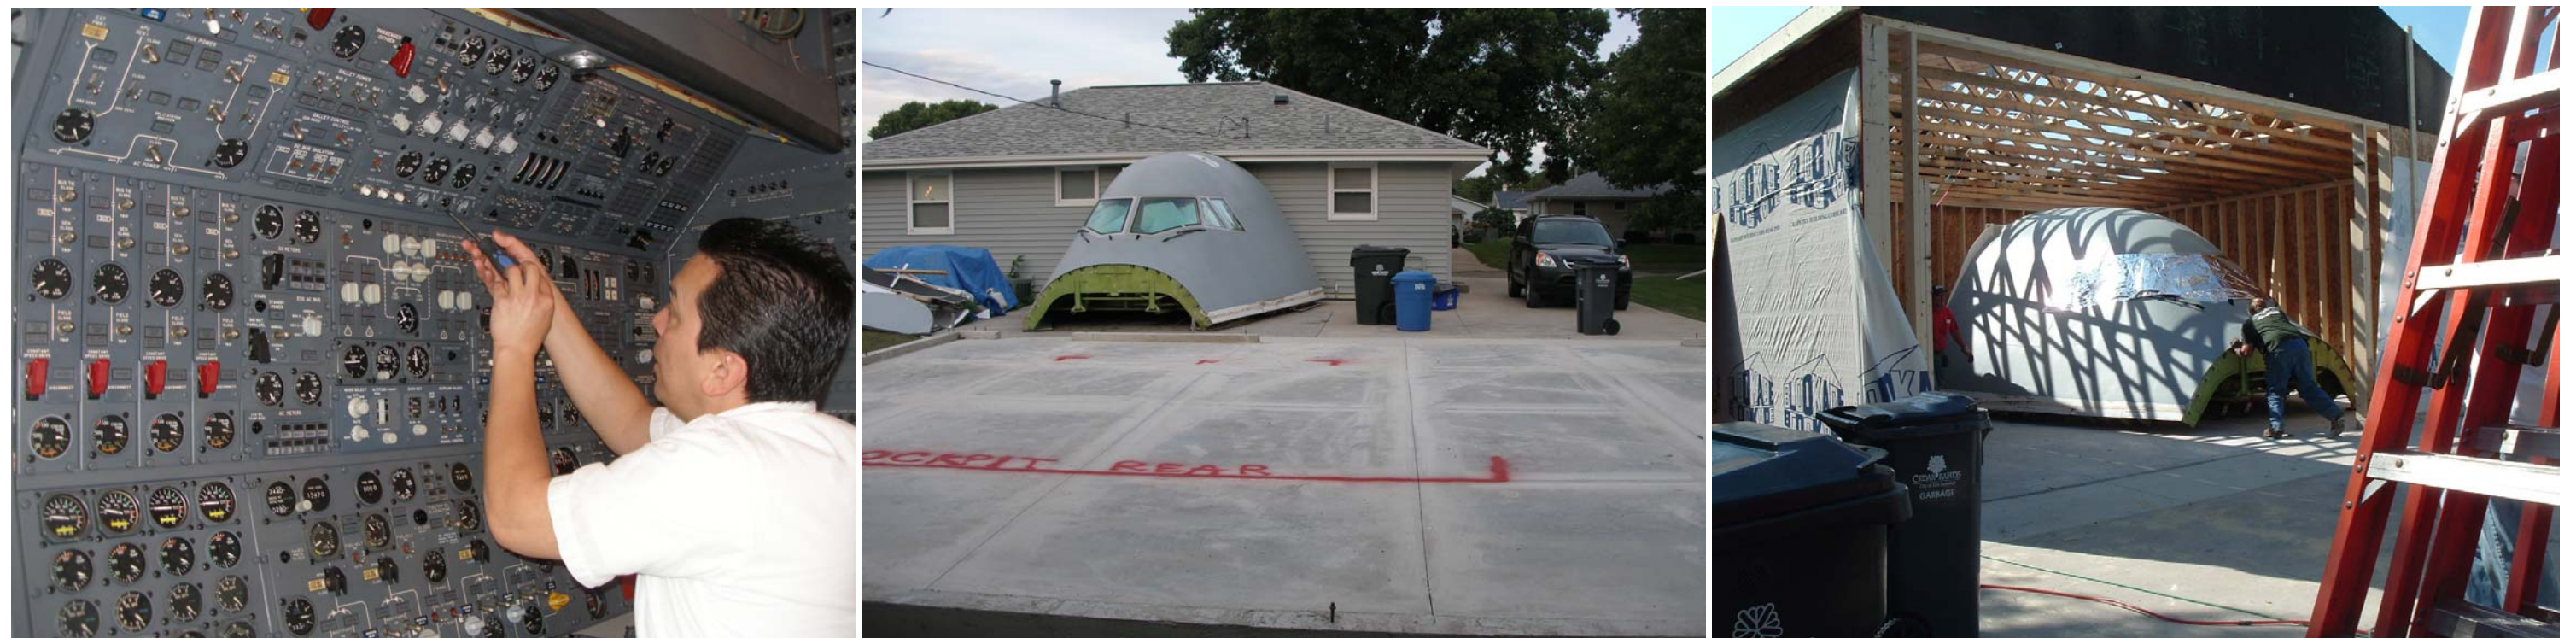
Instruments were temporarily installed before the cockpit was separated from the house destined for its new home in a large garage. I had a garage built as large as the city would allow to give me plenty of room to move the cockpit around. As before, industrial strength dollies made moving the 5500 lb cockpit super easy. Now it resides out of the elements and also stops my house from being a tourist attraction. Restoration, wiring, and spare parts acquisition is ongoing.

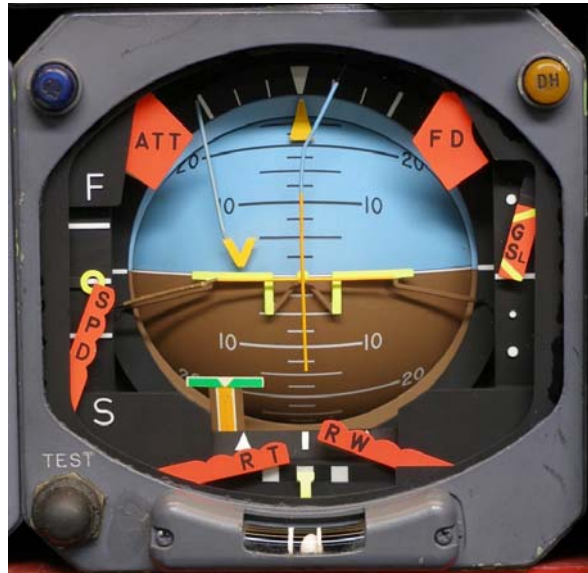
Sperry type ADI

The front instrument panel depicts mostly a Collins Avionics suite of primary instruments. Collins uses a moving tape in its ADIs to display the pitch portion of attitude while other avionics manufacturers, such as Sperry, use a physical sphere within the instrument. Luckily, the indicators are virtually pin-for-pin compatible and exchangeable without changing electrical connectors. I prefer the Sperry sphere type attitude representation, seen below, and will most likely install that model of ADI.

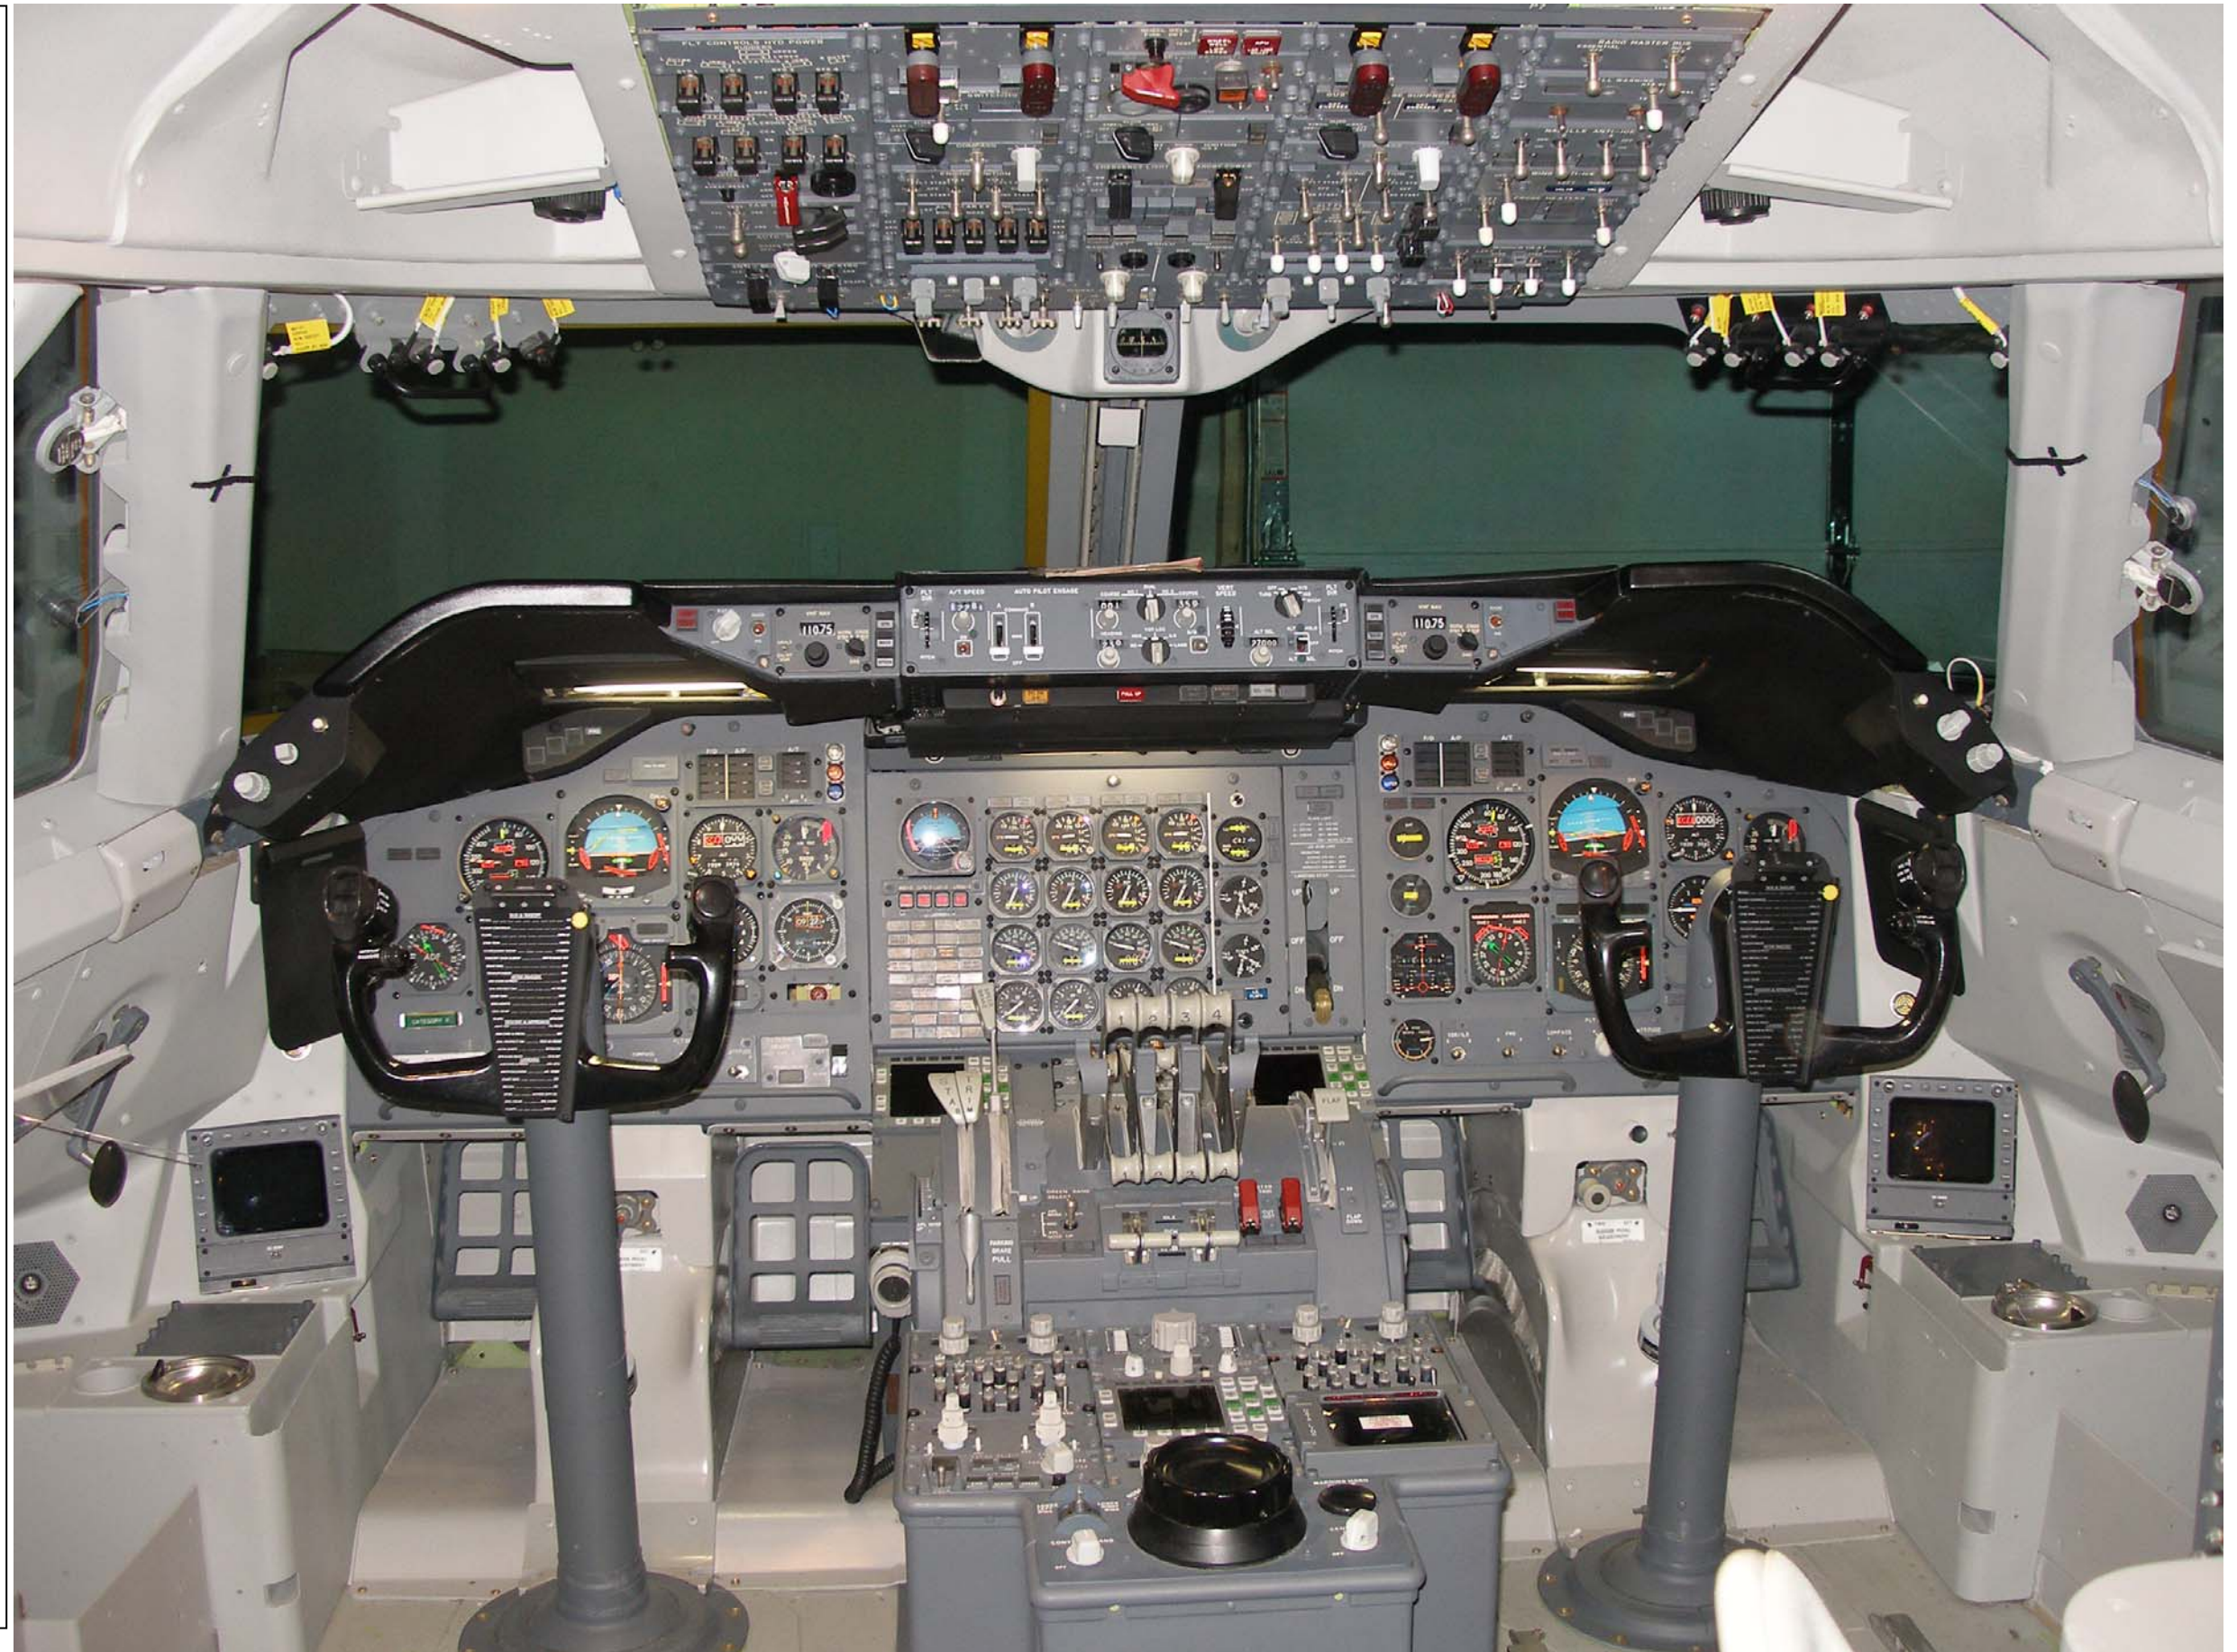
This picture, taken 5/29/12, shows the current state of the cockpit which still has a lot of restoration left to be accomplished. Oxygen masks, decals, original carpeting, crew seats, headsets, and a myriad of other small components remain to be installed.

Plain and shielded cabling has already been put in place behind the panels and walls to accommodate versions of the 747-300 that have been upgraded since 1986 to present. Traditional Litton INU CDUs can be installed or replaced with modern full FMS CDUs with six line color displays. The ADI and HSI can be replaced with LCD replacements and a display control panel to support their different modes. This enables the cockpit to be configured as it was originally delivered in 1986 or updated to current regulations requiring TCAS, Mode S transponders, EGPWS, etc. Multiples of each type of each manufacturer's instruments and control panels have already been acquired to enable support of the simulator for years to come. Reconfiguration of the cockpit as a whole is fairly easy since Boeing used standard dzus rail panels just about everywhere.
