Boeing 747-300 Cockpit Restoration Project Timeline & Development

For end use as a home flight simulator

Boeing 747-3H6, Serial number 23600, Total aircraft hours: 64141, Total cycles 13470, Last registration: B-KAC Dragonair Cargo, (Cathay Pacific) Hong Kong

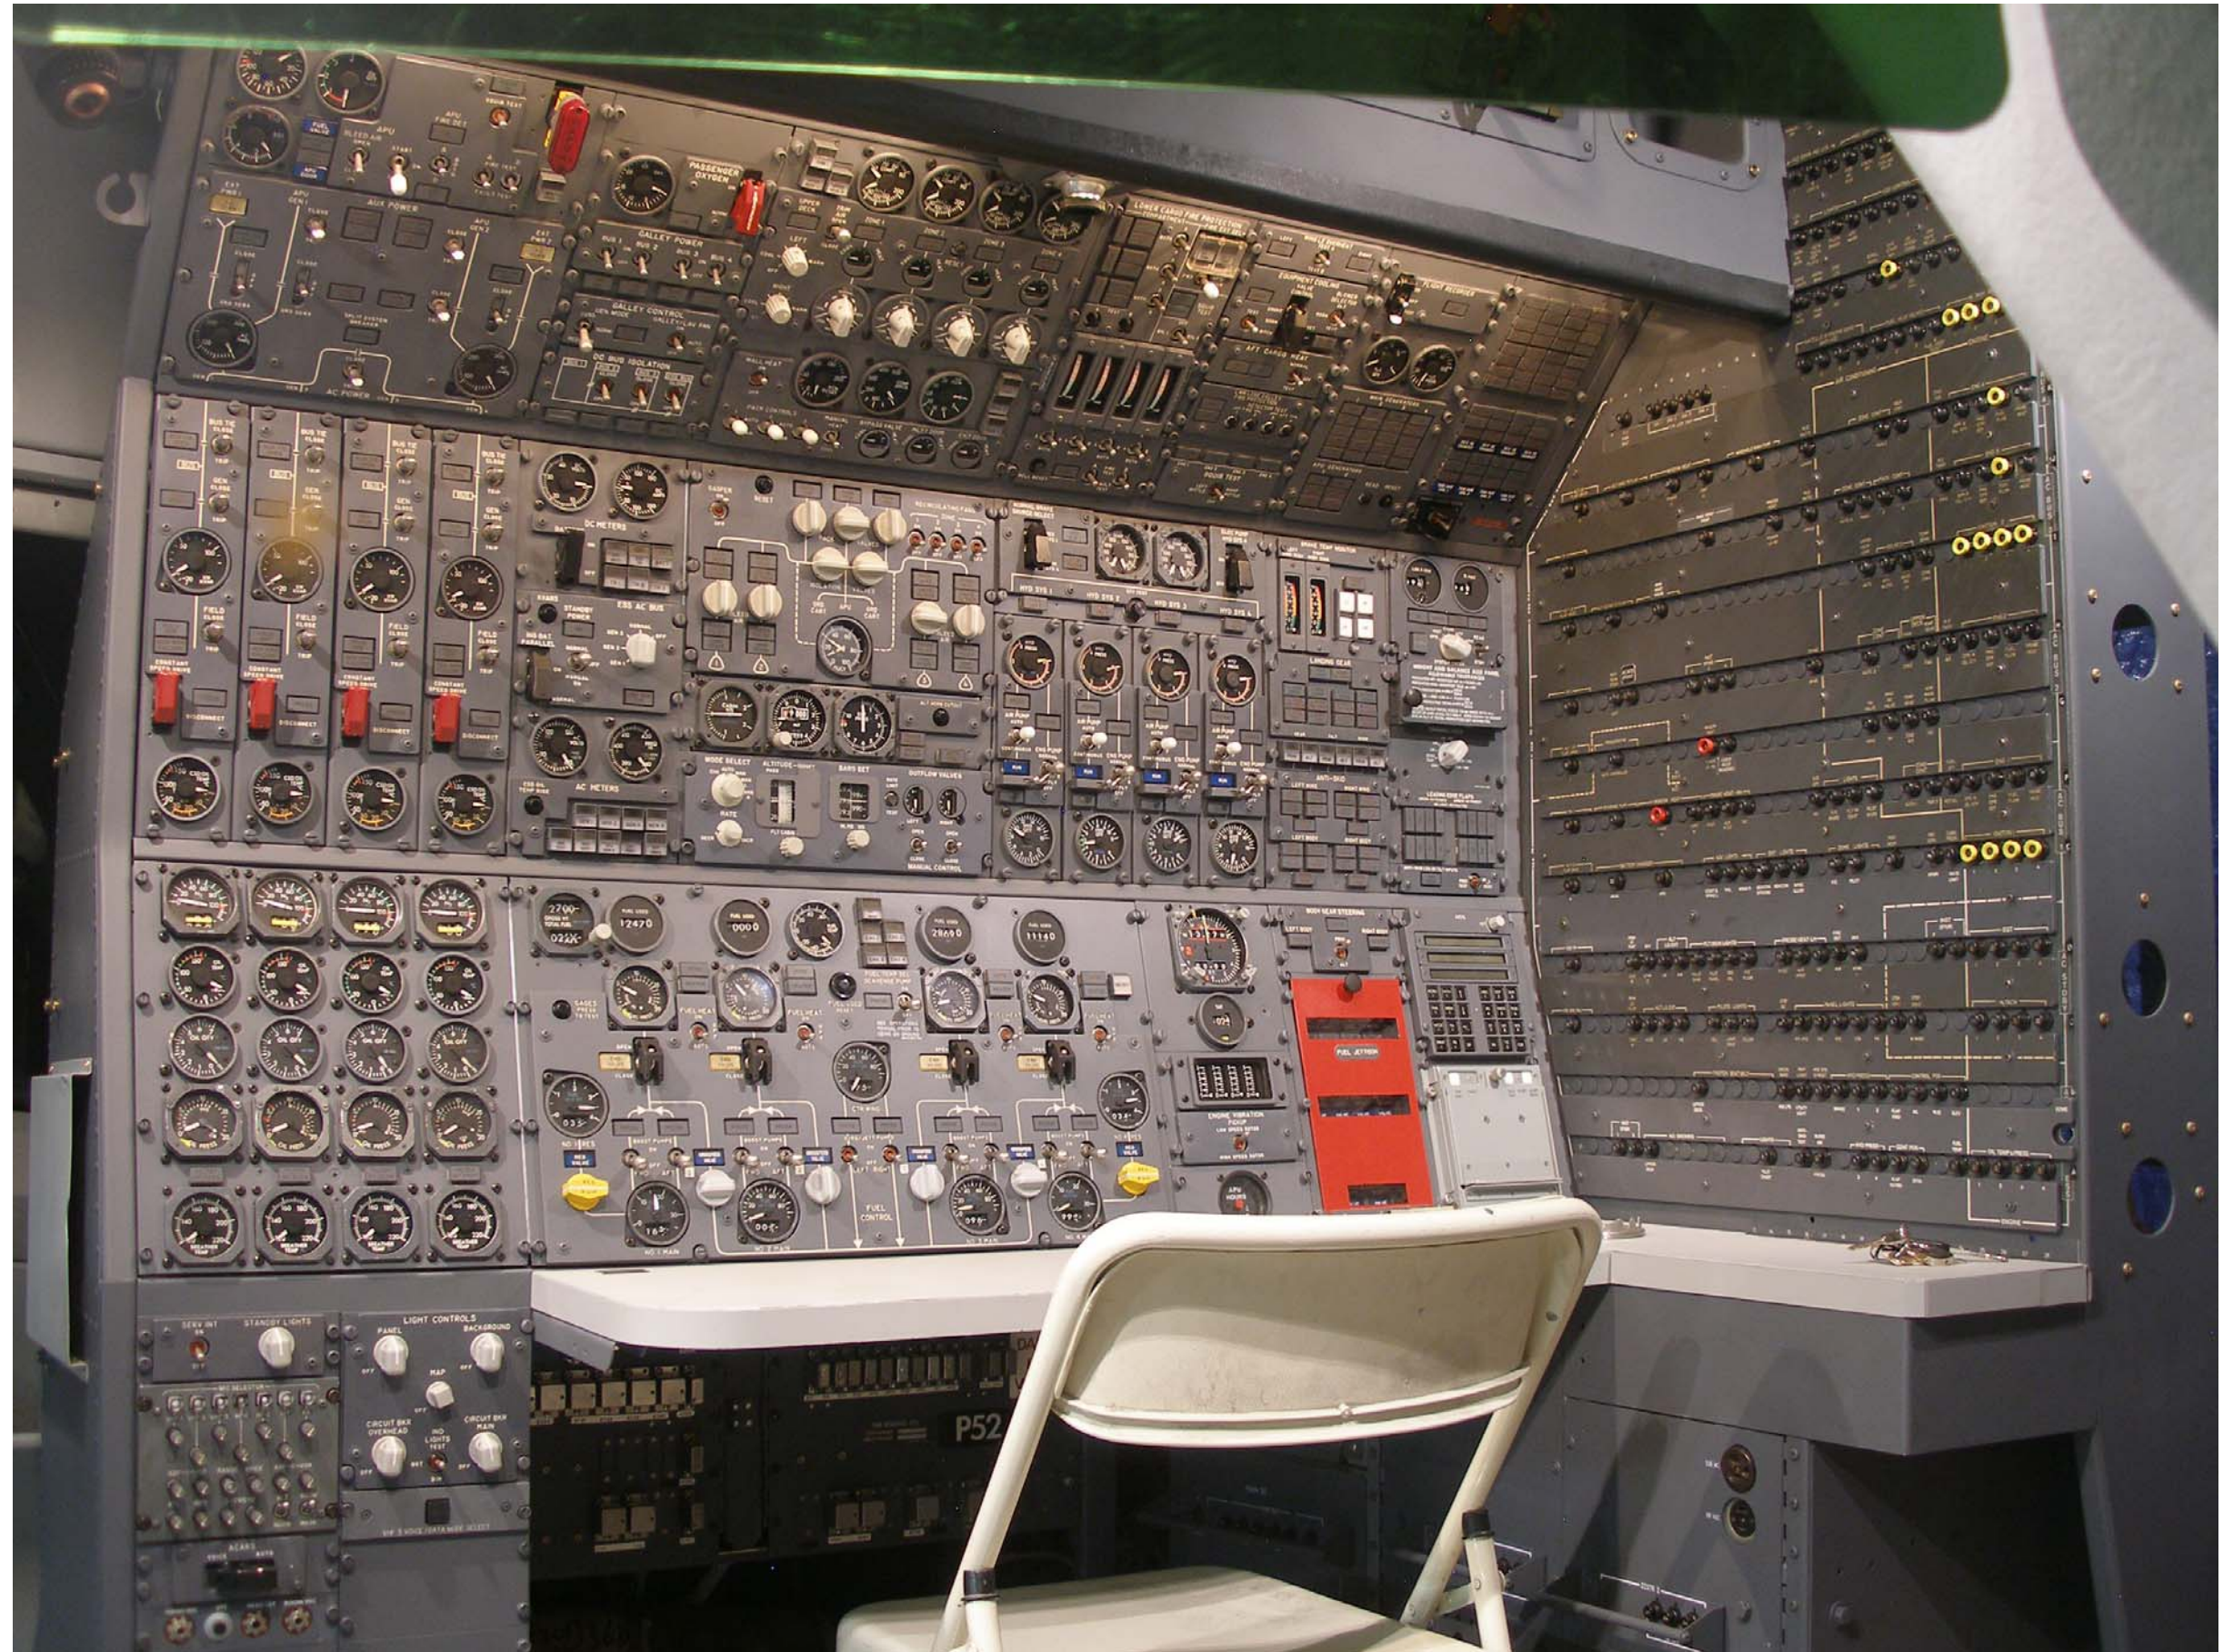
The 747 Flight Engineer's station layout varies between different airlines depending on the options they chose when they bought the aircraft. Some fuel panels are far less instrumented, the engine gauge grouping on the lower left can vary to exclude the engine breather indicators and, of course, many other panels change depending on if the aircraft will be a passenger or cargo jet. Many panels are standard, such as the APU panel, generator panels, etc., but there is a lot of room for carrier-specific equipment such as ACARS panels and printers. Some carriers choose not to include a brake temperature monitoring panel, or other panels that may appear on other jets. No doubt I will change the panels at the FE station many times, but as with the main front panels, cabling will be in place to accommodate updates such as digital fuel indicators and data link equipment.

During restoration, even the smallest unseen components, such as relays, static inverters, transformers, logic modules, etc., were removed, cleaned and await reinstallation. Every single of the hundreds of electrical connectors were removed, de-pinned, cleaned and await fresh pins to be reinserted. The spider web of air ducts, plenums and hoses behind the panels were either cleaned or replaced and air is already being forced through some of them. As much as practical, circuit breakers will be wired to their appropriate loads. As most of the breakers connected to equipment outside of the cockpit, they will simply remain disconnected.

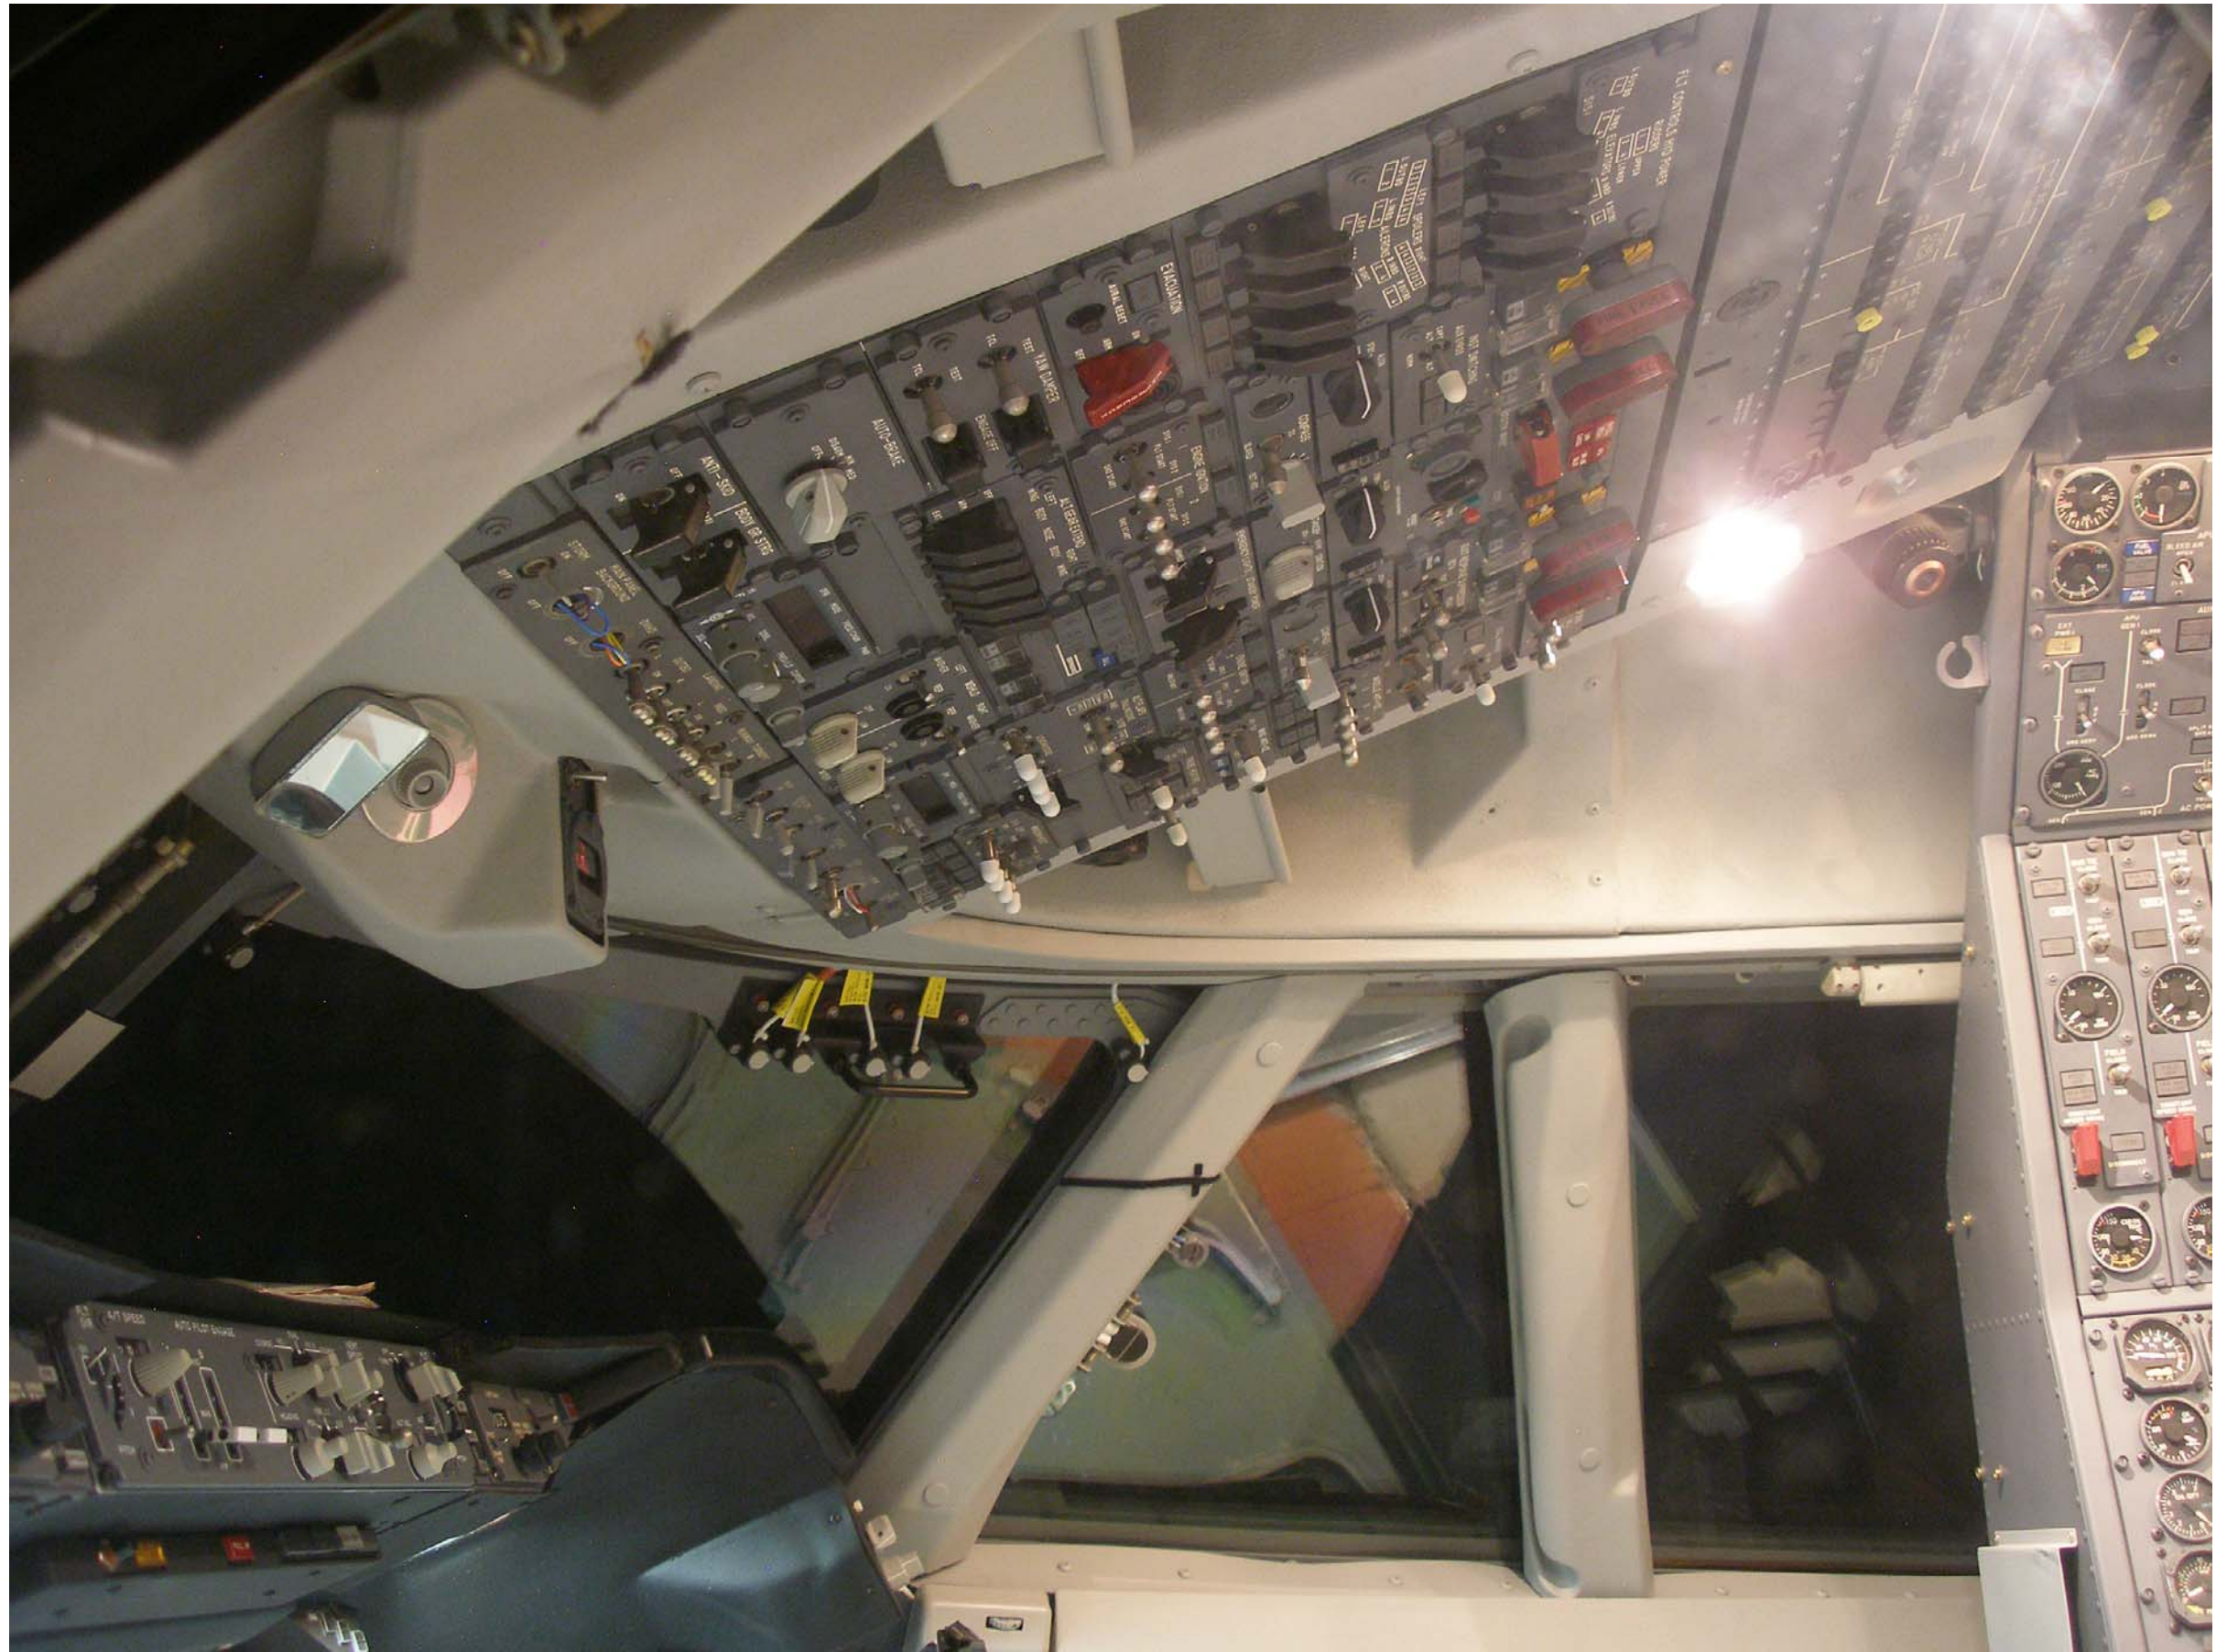
Shot through a dusty exterior window (Geez, I could have just wiped it off with a rag!) the overhead panel can be seen. Most of the control heads for the overhead have been restored, but you can still see the wires leading out of the forward part of the panel indicating I have not installed dimming potentiometers and knobs at those locations. Right now, all of the interior lighting is set to full bright.

You can also see the mode select panel, which if you did not notice earlier, is a Category II panel since it does not have a third engage lever. The autopilot, flight director and autothrottle mode indicators are also for a CAT II system, but if you have a keen eye, you can see the center engine instrument panel has flag indicators for a CAT III autoland system. The mode select panel and associated mode select indicators can be exchanged with CAT III versions, but as most airlines simply found the analog CAT III system too hard to maintain, they usually taped over the third autopilot lever and marked it as "INOP". I have the parts to change over to a CAT III system, but prefer the pilot of this simulator to manually flare out and land the plane. As the human interface to this old analog world is the most attractive aspect to me, I hope to keep as much of the analog systems running as possible. However, it is always nice to have the ability to upgrade to modern displays and flight management systems.

I've been asked why those yellow stickers are on the window heating wires and the answer is that they exist on the real aircraft and these wire/cable marking identification labels are on every cable bundle behind the connectors. They are made of self-extinguishing Tedlar material and I use the exact same labels on the wiring in this restoration.
